Some of the following information was published in Bulletin 40 1/82 of the Springwood Historical Society. Other information obtained by scanning old news articles.

It was thought that in 1913-14 a steam driven timber mill built (either by Joyce alone or the proposed company) in the Linden Creek valley on a small tributary to Linden Creek . A 900 metre long one metre gauge tramway incline track was built using 4 inch hardwood rails fixed to rough bush sleepers with some on a raised track bed over the difficult terrain. When you see the remains of the boiler today it is hard to imagine how it was transported to the valley floor as it is estimated

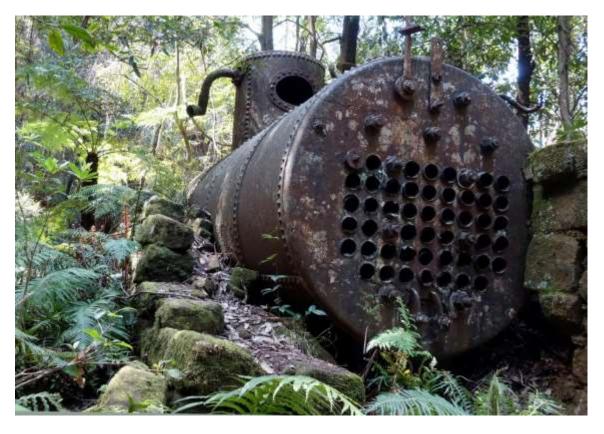
Boiler on Site. Chimney Housing and Firebox Door Missing

The boiler at this site is 12 feet long, 6 feet diameter with 48 4 inch fire tubes. Some fire tubes have been sealed due to steam leaks. The boiler is mounted between sandstone block walls with its brick firebox underneath. By checking the diagram below we can see the housings on the ends are missing one being the baffle that directs the flue gas into the fire tubes where it exits up the chimney. The steam generated flows into the header on top of the boiler. Feed water is injected into the boiler via the pipe on the bottom of the boiler. This a fairly large boiler of this type and would require a lot of wood and water to keep operating. It is estimated that there is 950 square feet of surface heating area which would evaporate around 3800 lbs (380 gallons) of water per hour generating 60 HP for a boiler in peak condition. I suspect that this boiler wouldn't in peak condition as several fire tubes had failed and had to be sealed.

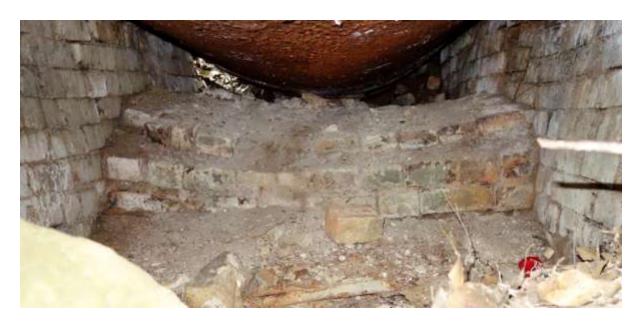
Firebox lined with Fire Bricks

It appears to be missing a grate assembly fitted to this boiler. The effect of the fire on the boiler shell can be seen.

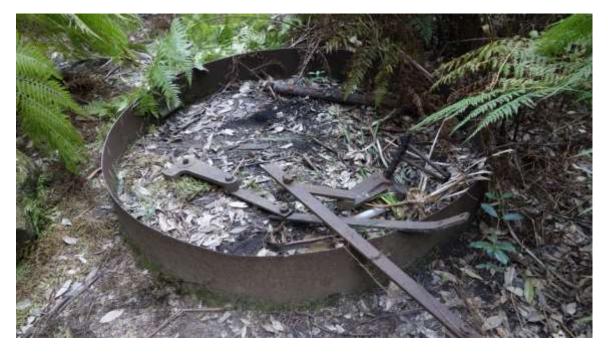
**Unknown Parts**

The parts in the photograph above have been previously described as a flywheel which isn't correct. When researching machinery used in the early 1900's it appears to be a brake band as used in strap

brakes and its operating lever assembly. The band fitted around a large wheel on a winder for example and by pulling on the brake lever the band tightened on the wheel to slow its motion..

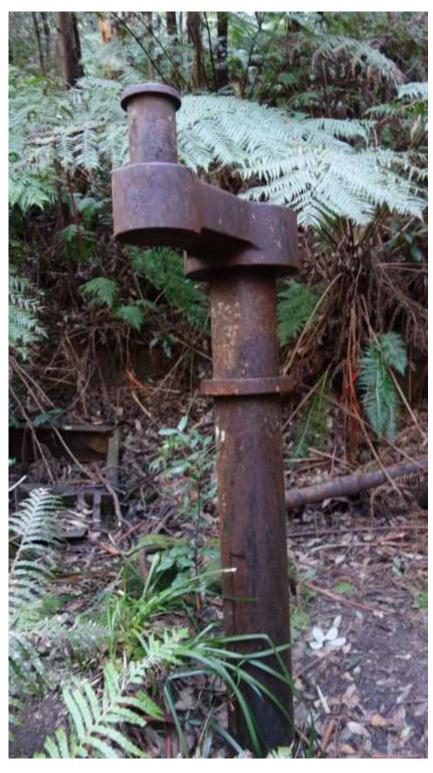
Located near the boiler is a large steam engine 18 inch throw crank shaft buried in the ground. Why this item was left in this way is a mystery. It would have been from a large engine and one suspects that it is possible that it may be connected to a flywheel which is buried. In the background on the left can be seen the frame for the firebox door while on the left is some of the steam or water piping laying about the site.

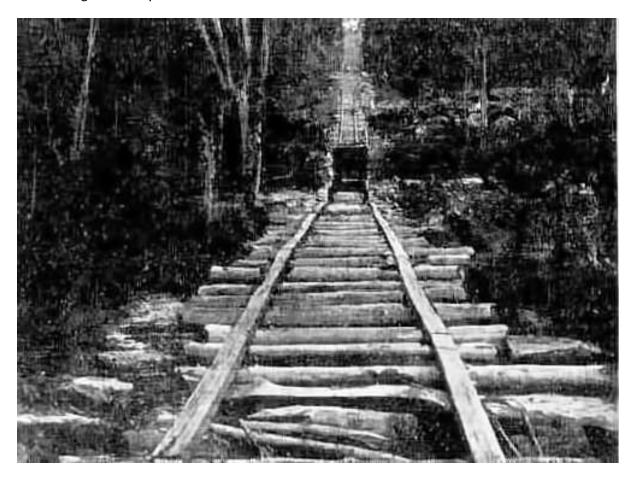
Print in SMH Newspaper article February 1912

This cleaned up print published in the SMH February 1912 article about the Defiance Cabinet and Chair Making Company building a railway to lift timber out of the Grose Valley. . It has 4 inch hardwood rails on rough bush sleepers. The article stated it was taken from the top, however, there isn't any sign of the haulage cable from the winding engine to the carriage. The resolution is poor so we cannot have a good look at the carriage and its wheels. Further investigations have revealed that this incline could be one in the Parkes Estate area and checking streets in this area was found to be very close to Martin Place Faulconbridge. This photograph may not be our incline as it would have been on the other side of the ridge to the Grose Valley

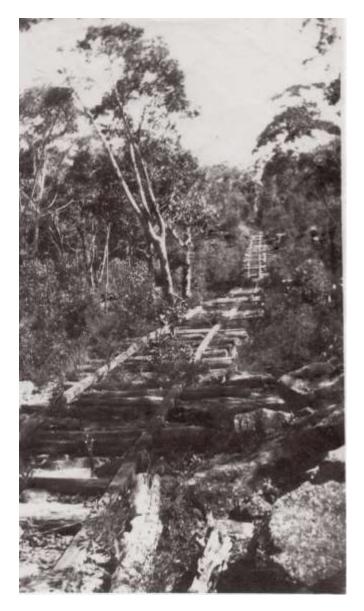
Parkes Estate Incline

The photograph below from the BMHS collection is supposed to be an incline in the Parkes Estate. The incline is obviously showing a neglected structure. There is no record found of an incline in Faulconbridge other than the Linden Creek incline. Looking at the two photographs the inclines look similar. The Linden Creek incline we think had metal covering over the rails to stop wear on the rails (metal found in the bush near the incline track). This incline doesn't have this covering.

If the photographs we have are not of the Linden Creek incline its construction would be similar in appearance. The lay of the ground at this site isn't flat and it is said that the incline was built up on timber frame work.

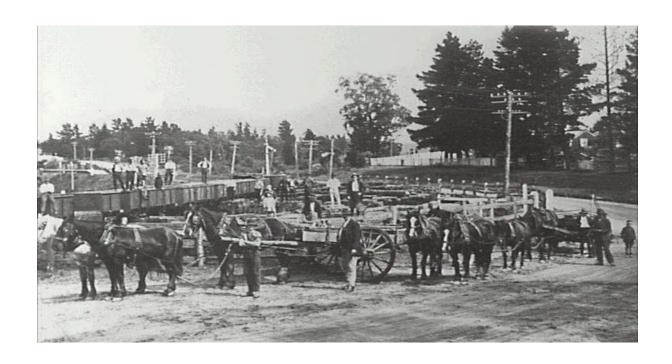
Thel 1922 photograph from the Blue Mountains Collection is the unloading of railway sleepers carried from the sawmill by horse and dray to Faulconbridge Station to be loaded into railway trucks for delivery to their final destination

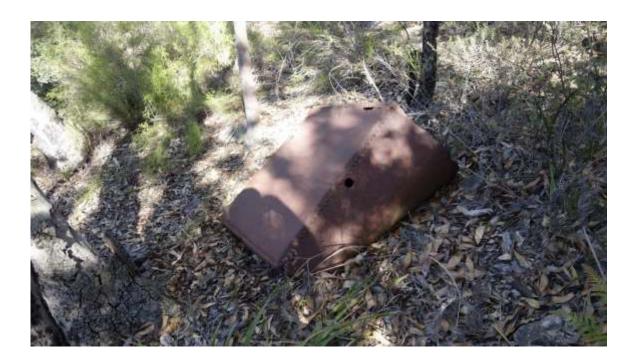
Remains of several steel tank on side of access road. Further along the track is a possible dam.
