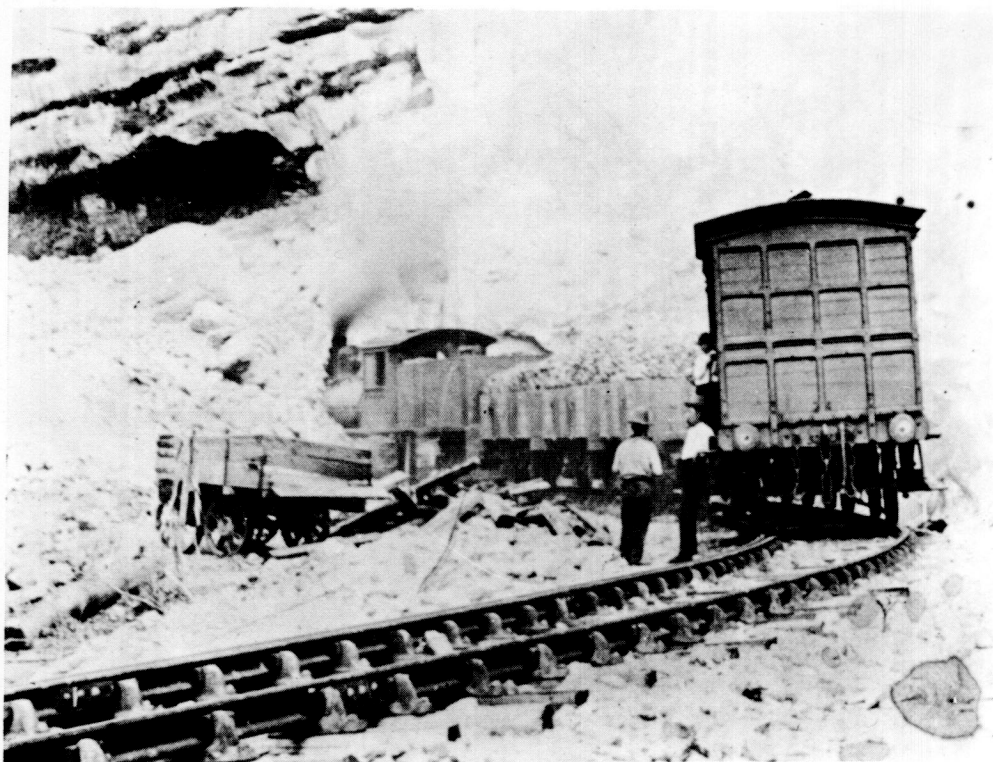
*Ex-N.S.W.G.R. brake van No. 10860 in use on the Wollan Valley Railway, June 1908.*

one end, sliding doors fitted with two windows were placed near the other end. They were roofed with corrugated-iron, slightly curved for strength, and held in position by longitudinal battens. It has been stated that on occasion horses were conveyed in these vans, quite a messy business one should imagine. They were also used for passenger traffic at holiday times. On May 19th 1921 we read "Last week an accident occurred on the Newnes line. An oil train drawn by a Shay engine was proceeding up the hill towards the junction and when between the nine and ten mile pegs, three full tanks of oil and the brake-van, by some means, became detached from the train and raced back in the direction of Newnes at a tremendous speed. Over three miles were covered before the tanks became derailed on a short radius curve. Two of the tanks and the brake-van were badly damaged. The third tank was practically intact and about six chains of track was badly cut about". It is surmised that the side ducket of this brake-van was torn away on this occasion and was not replaced. To the end both brake-vans bore the red stencilled circle of the period denoting a "piped" vehicle, although

they were fitted with continuous air-brakes when last seen. When sold to the Australian Iron and Steel Company they both had their wheels, axles, and undergear removed at Newnes preparatory to being transported on a low loader to Wallerawang. Here they were placed on a Departmental flat truck and taken to Cringila where the bodies were used as fettler's huts placed at various locations around the steel works.
