Hadley Park

Conservation Management Plan

Revised Report

Report prepared for Penrith Lakes Development Corporation
September 2013

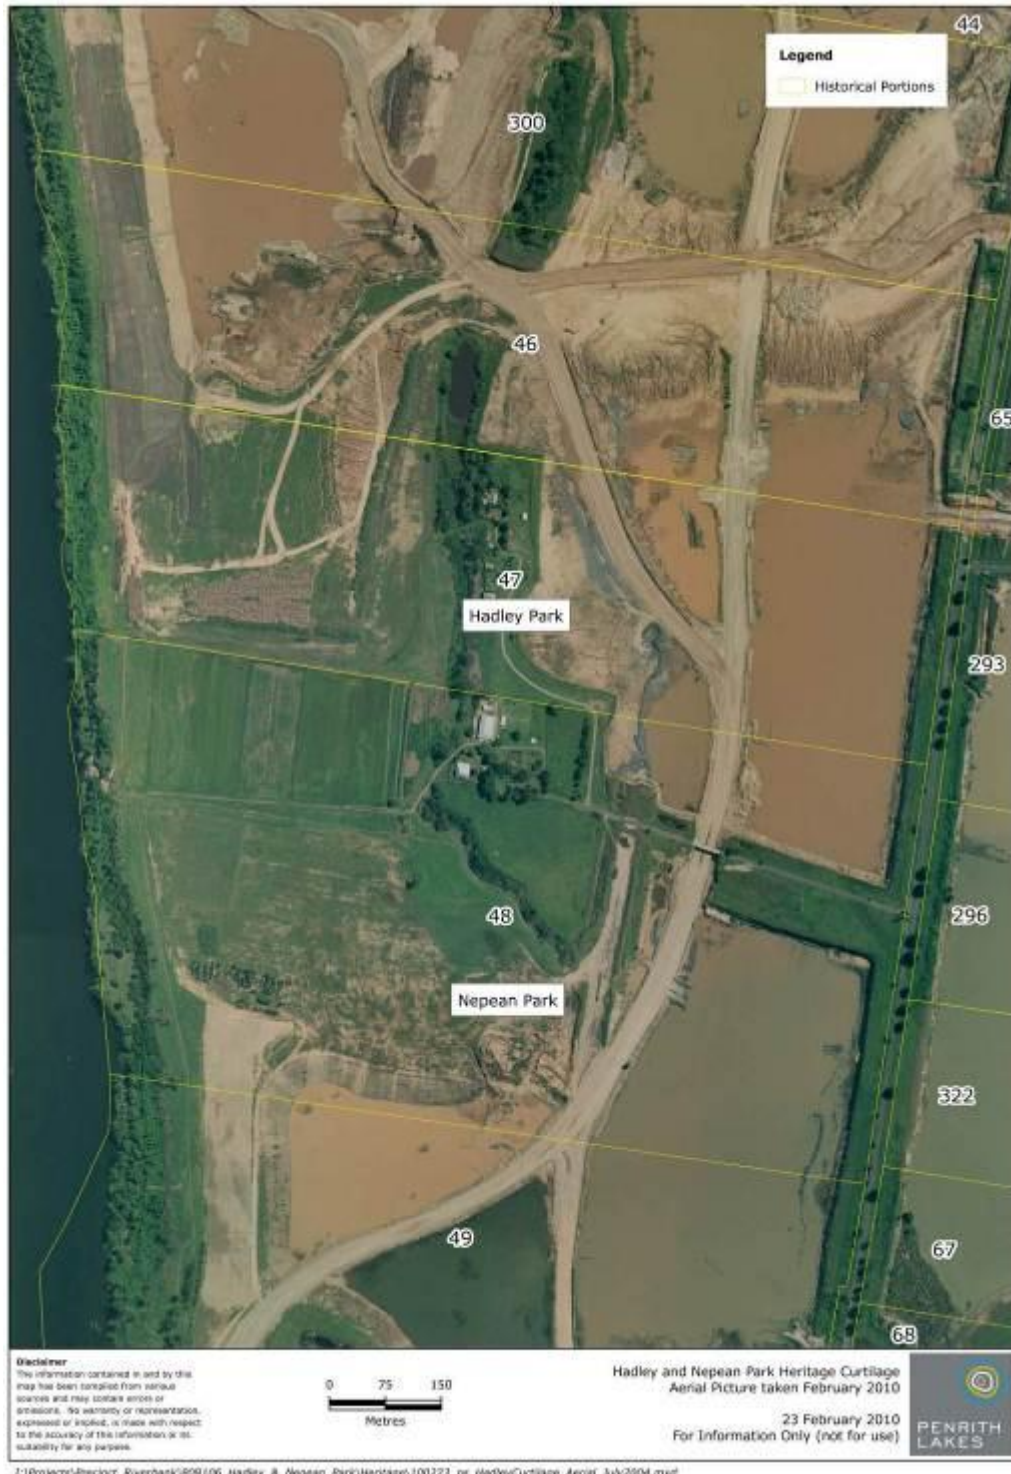
Figure 1.3 2010 aerial showing the original 1803 land grant boundaries of Hadley Park (portion 47). (Source: PLDC)

Note: Hadley Park core (shown in detail in Figure 1.4 below) is in the centre of the lot, with mining to the east, while the land to the west has been refilled after quarrying.

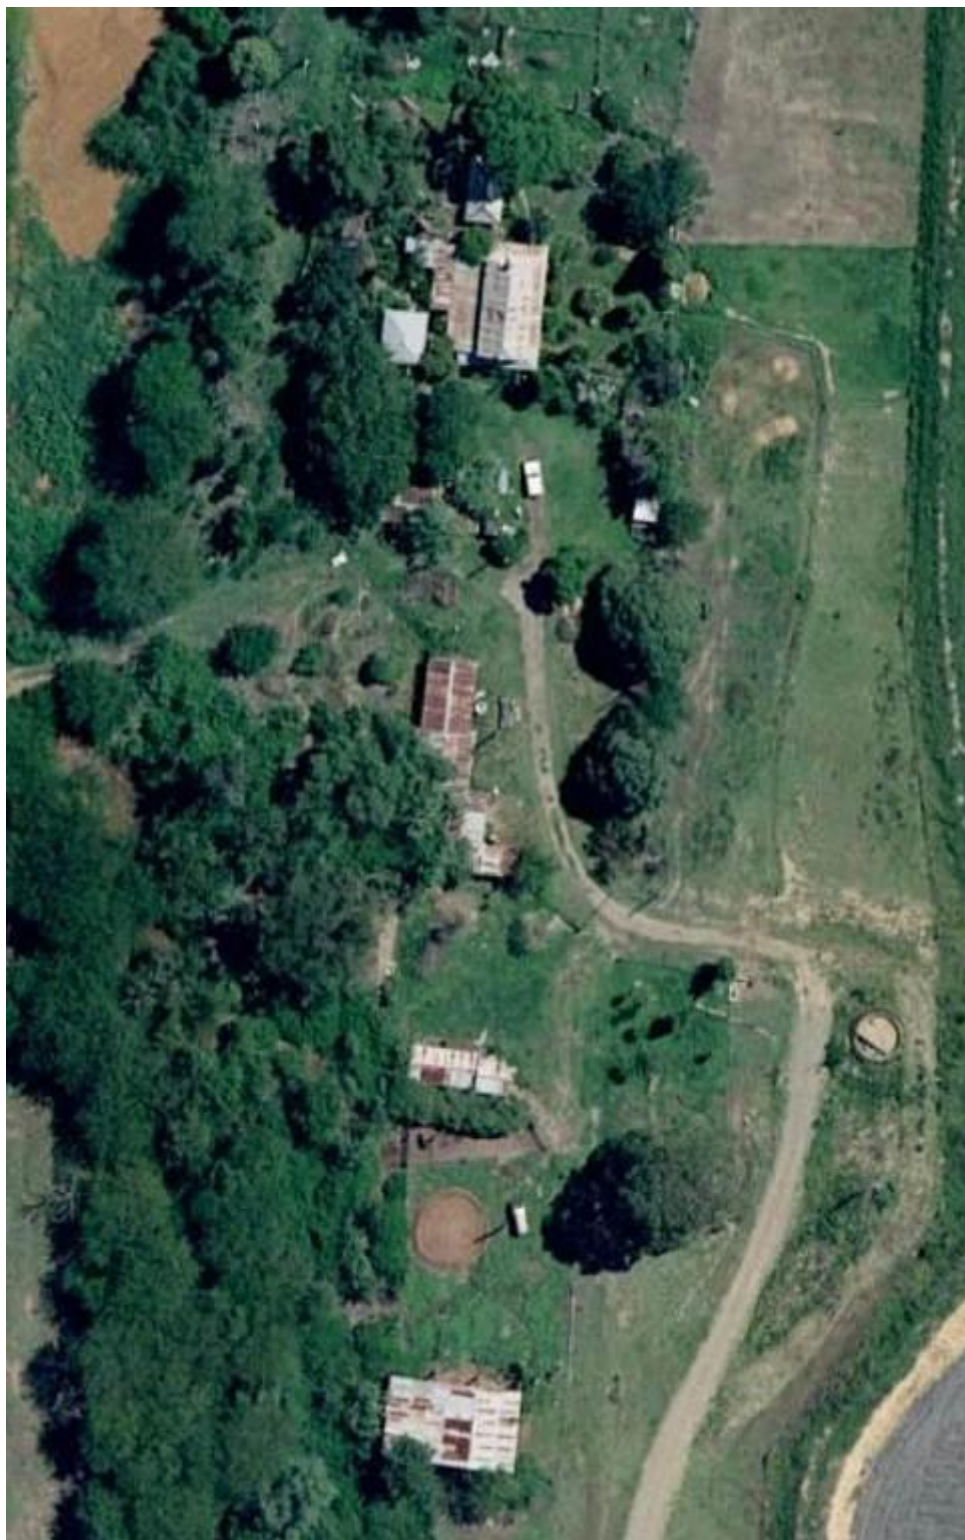
Figure 1.4 2010 aerial showing the existing buildings at Hadley Park. These buildings are described in detail in Section 3.0 of this CMP. (Source: Google Earth)

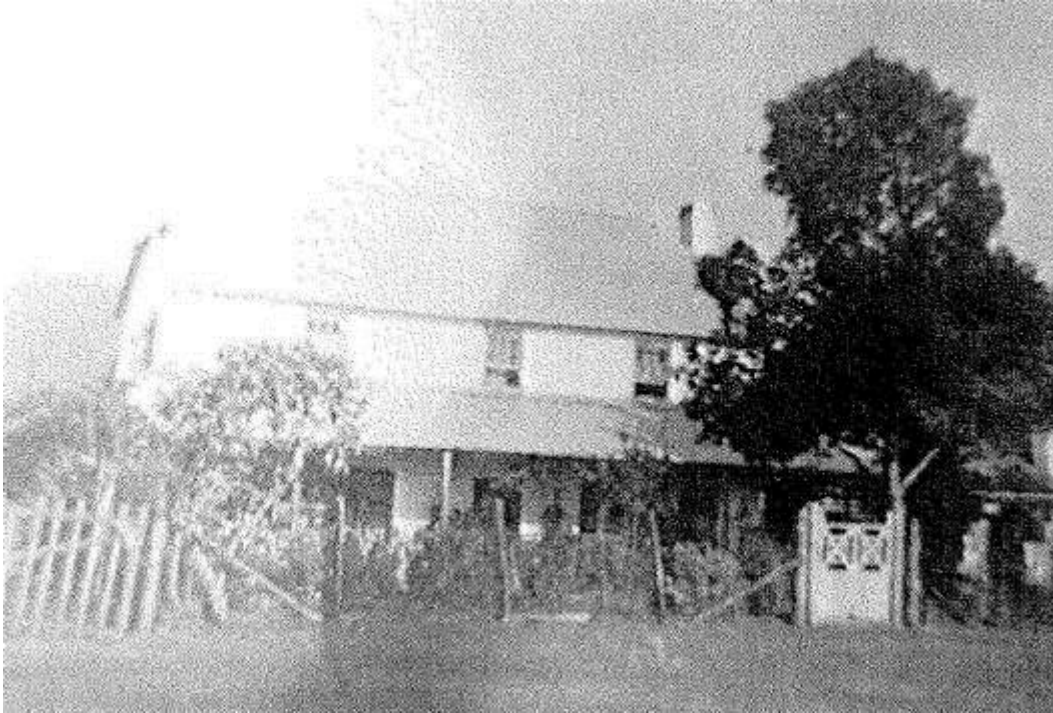
Figure 2.2 An undated (c1900) photograph of Hadley Park looking to the front of the house. Note: the picket fence to the left and the entrance gate separating the front garden from the front paddock. (Source: Penrith City Library Local Studies Collection)

Fencing to the front of the house separating the garden from the front paddock has changed from the picket fence evident in the c1900 photograph (see Figure 2.2) to a replacement with wiremesh panel fencing by c1965 (see Appendix F, Sections 2.1.4 and 2.1.7). Some form of ornamental bedding may have existed either side of the dividing path to the house.

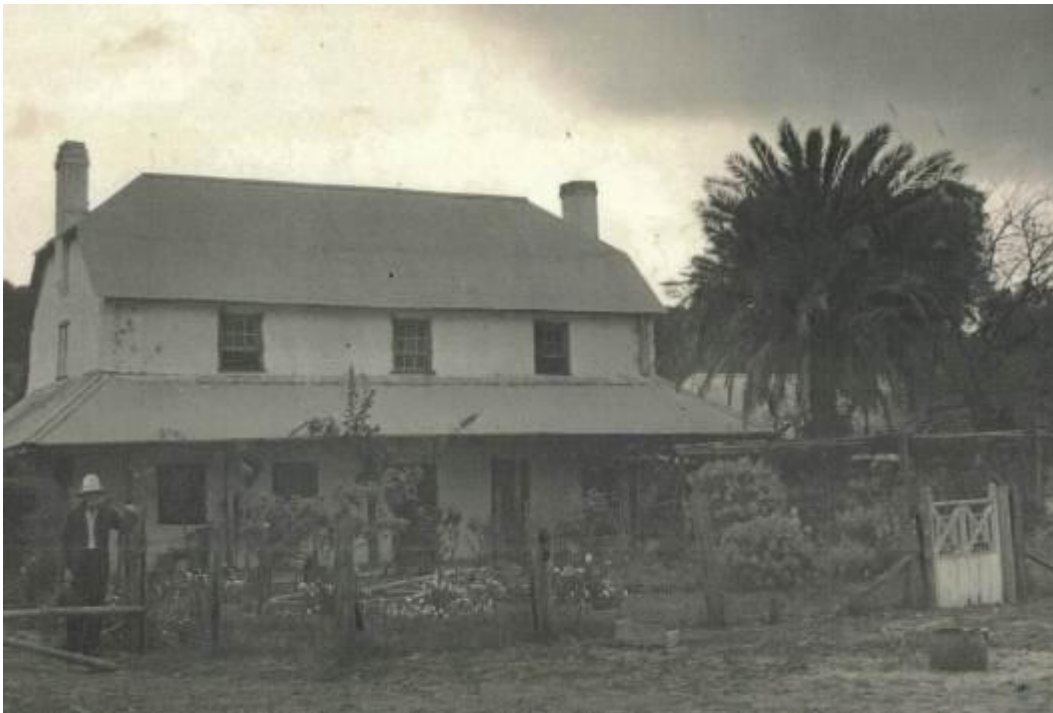
Figure 2.3 Undated (c1900) photograph of Hadley Park east (front) presentation. Note: the upper floor windows (now replaced) and the front gate and garden. (Source: private collection).

Policy 57—The later upper floor windows should be replaced to match the original multi-paned sash windows on the ground floor (see Figure 2.3).

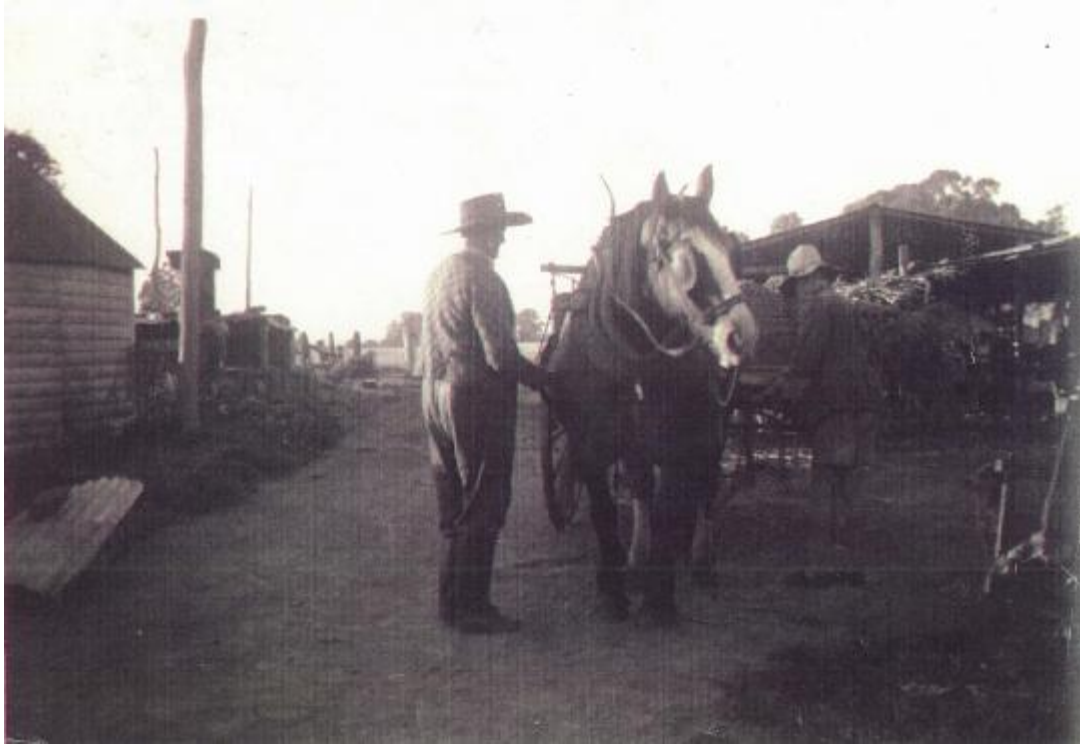
Figure 2.4 Undated (prior to c1950) photograph showing the cream shed in its former location closer to the road (to the left). (Source: private collection).

The former cream shed is a small post and beam structure with a gabled roof. It was moved from its former location slightly to the east (closer to the road, see Figure 2.4) and extended to the north in the 1950s–1960s to accommodate its recent use as a welding workshop.

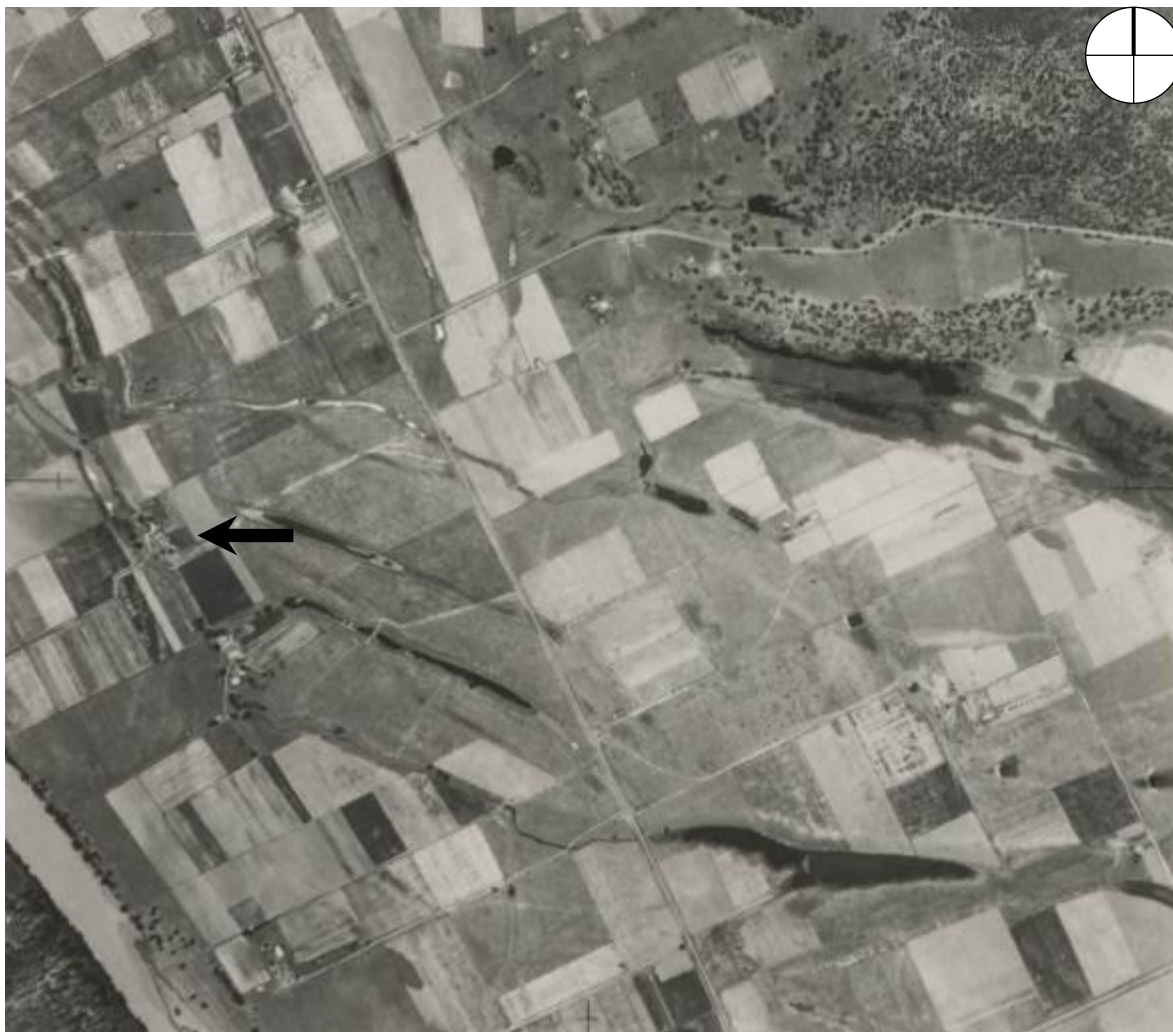
Figure 2.8 Detail of a 1940 aerial photograph showing Hadley Park (arrowed). (Source: PLDC). Hadley Park would have been partially visible from Nepean Park in the early years due to the lack of vegetation along the creek.

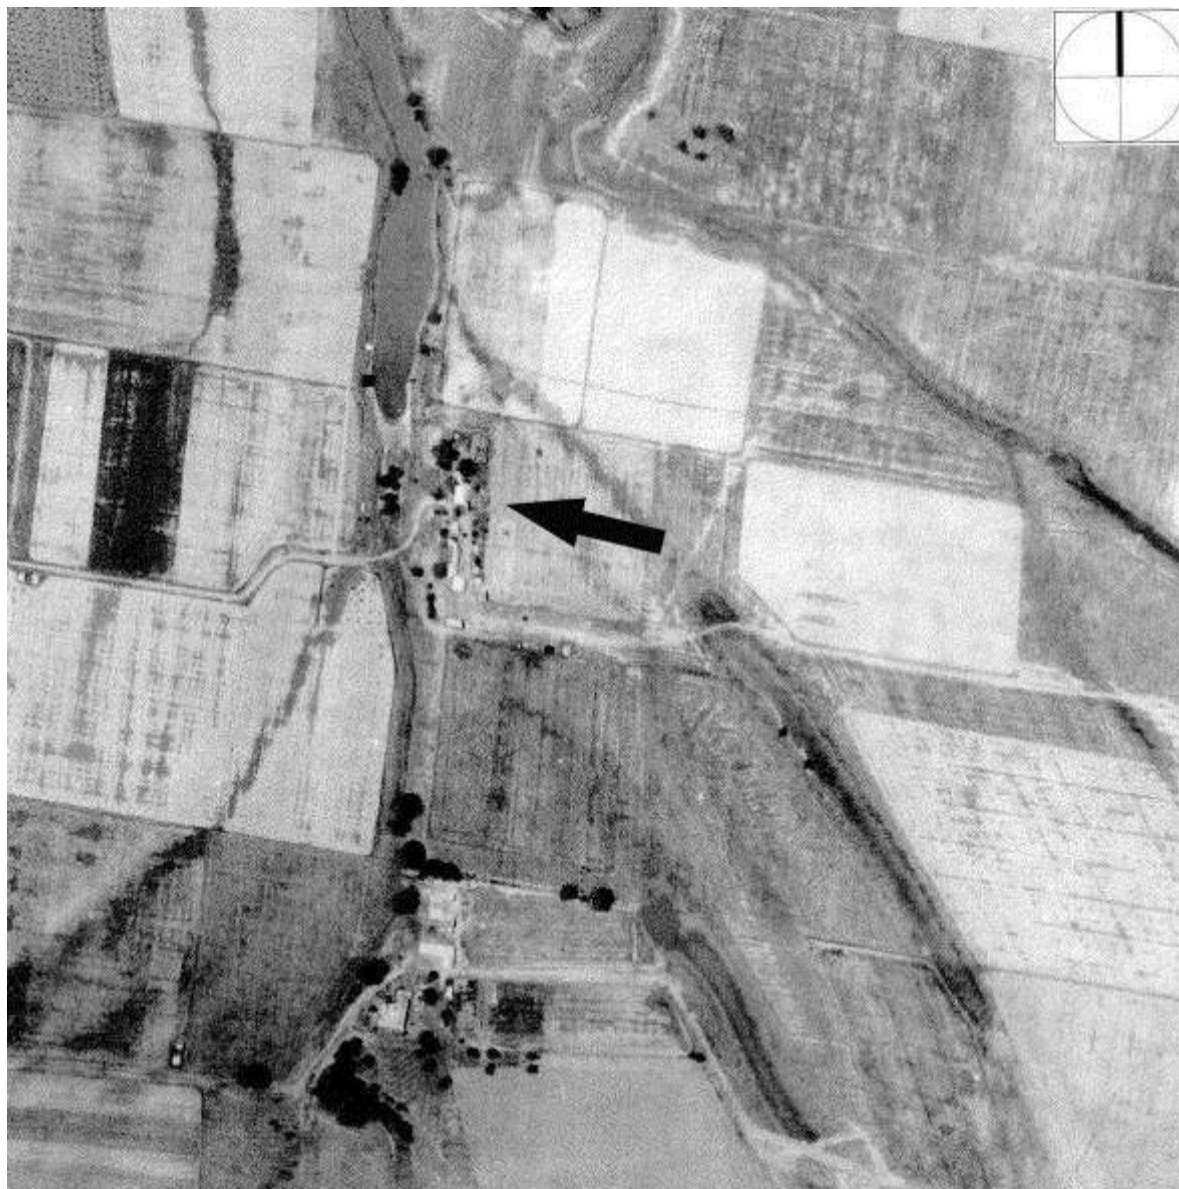
Figure 2.9 Detail of a 1947 aerial photograph showing Hadley Park (arrowed). The main farmhouse and outbuildings are clearly visible. The building to the south of the complex is the 1930s dairy. (Source: Department of Lands)

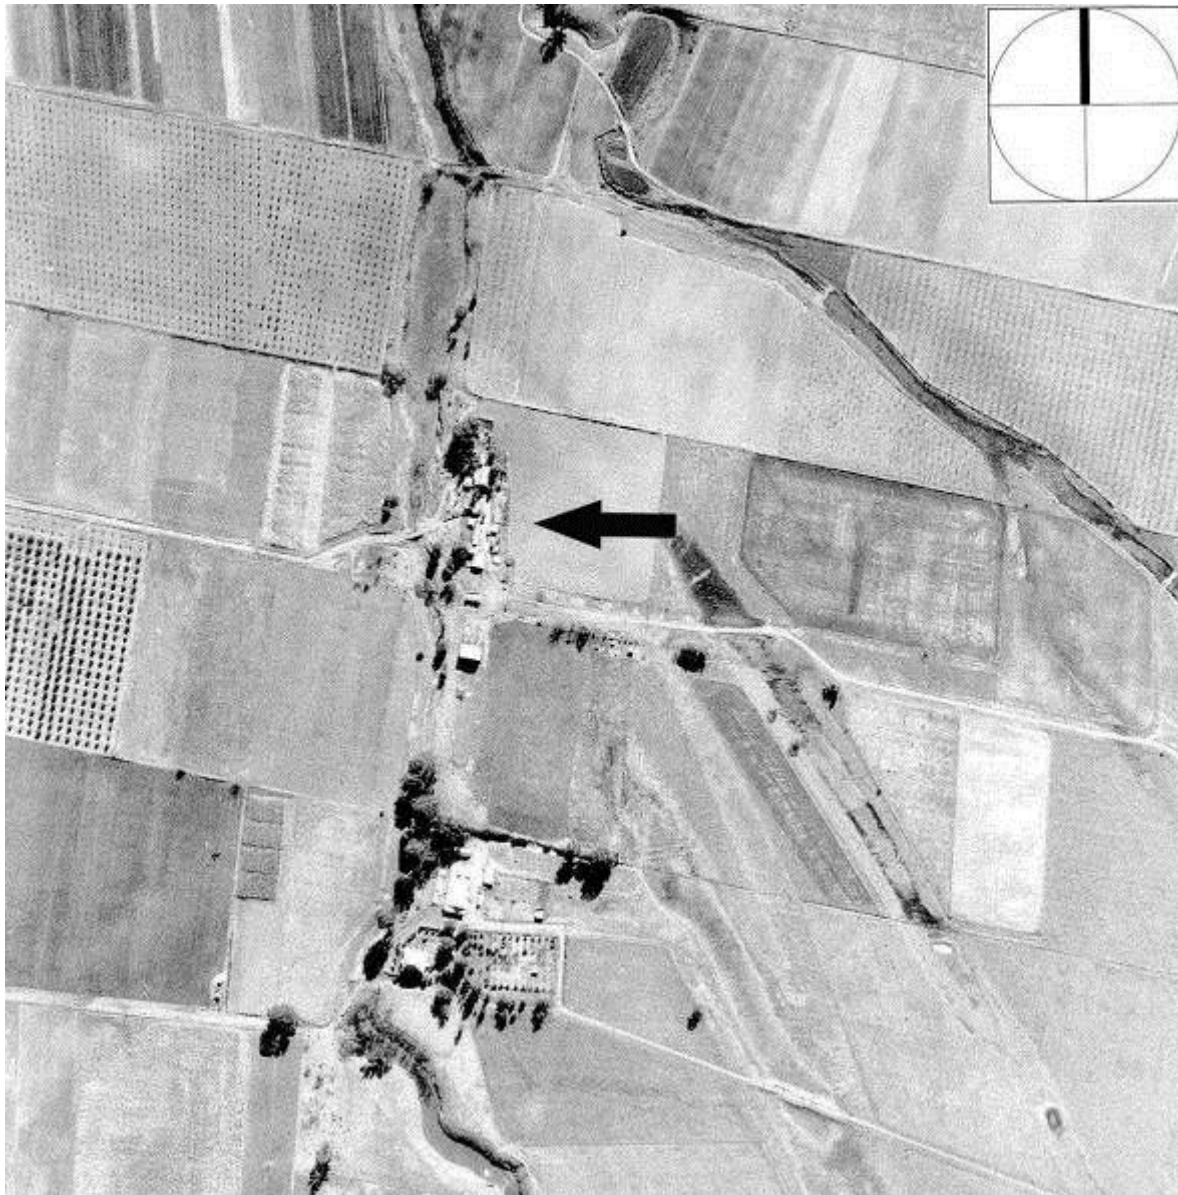
Figure 2.10 Detail of a 1961 aerial photograph of Hadley Park. Comparison to Figure 2.9 shows the new hay shed erected to the south of the dairy building. (Source: Department of Lands)

Between 1940 and 1961, a few changes were made to the site as evidenced through aerial photographs from the period. A new hay shed was erected to the south of the dairy buildings precinct and part of the southern portion (formerly Lot 2 DP 87060) was planted with orchards back to the river front. These had been removed by 1978 (see Figures 2.8 to 2.10).

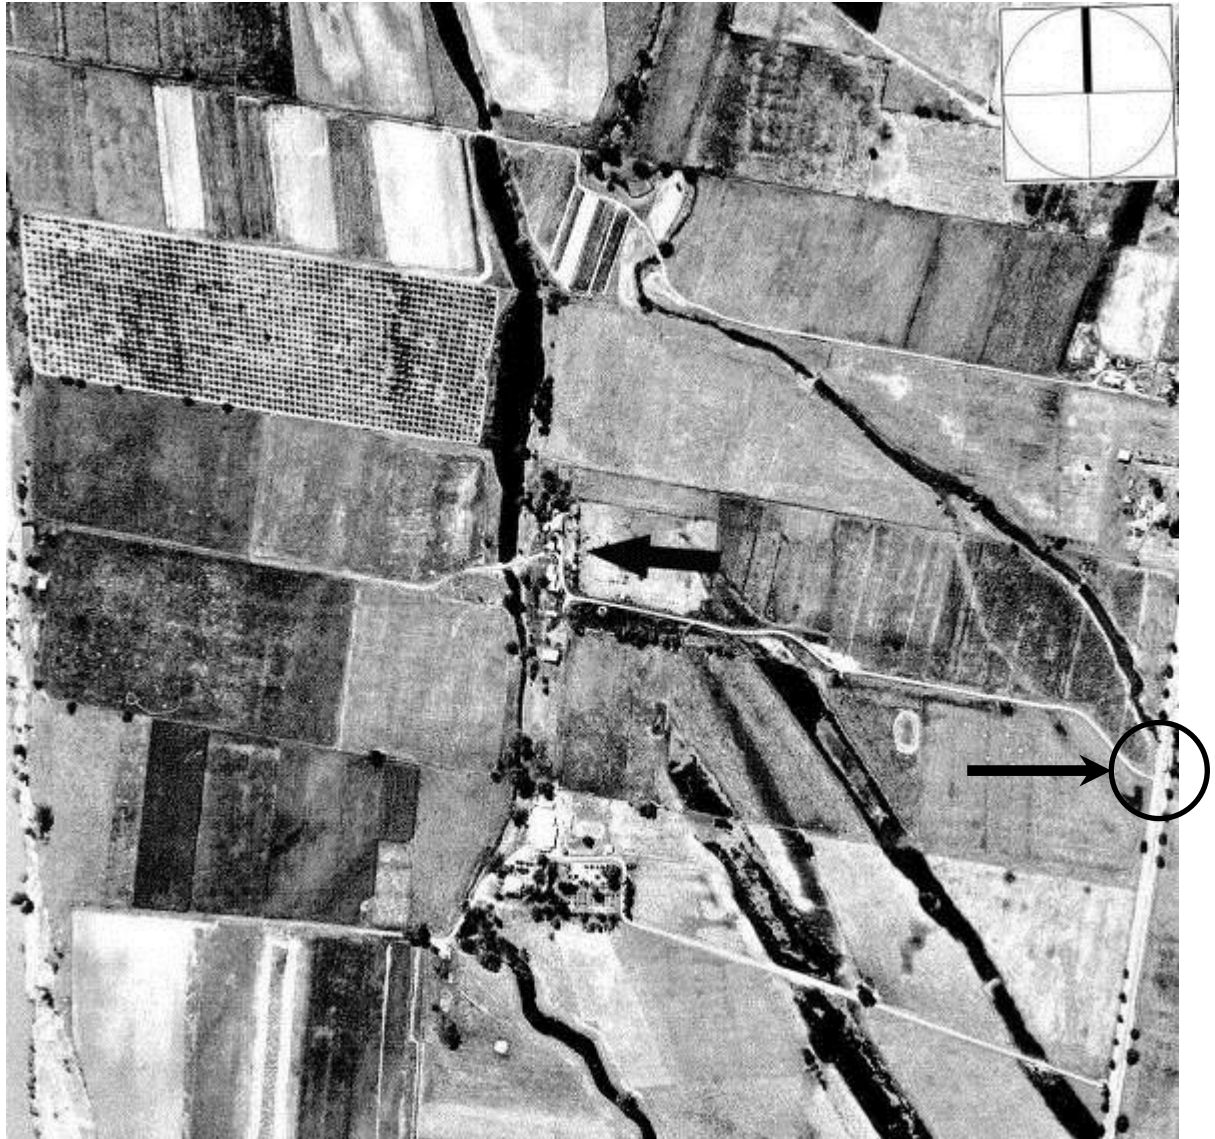
Figure 2.11 Detail of a 1978 aerial photograph of Hadley Park. The main entrance drive back to (Old) Castlereagh Road can be clearly seen to the right (circled and arrowed) as can the lagoons and Cranebrook Creek tributary that ran through the property. (Source: Department of Lands)

The earliest known road providing access from Old Castlereagh Road into Hadley Park was located about halfway across the historical grant and roughly parallel to the east–west boundaries. The entrance approach was from Old Castlereagh Road to the east, and then north into the open area south of Hadley Park House (see Figures 2.4, 2.8 and 2.11). A small portion of this early access road survives today (see Figure 3.7 and 3.9).

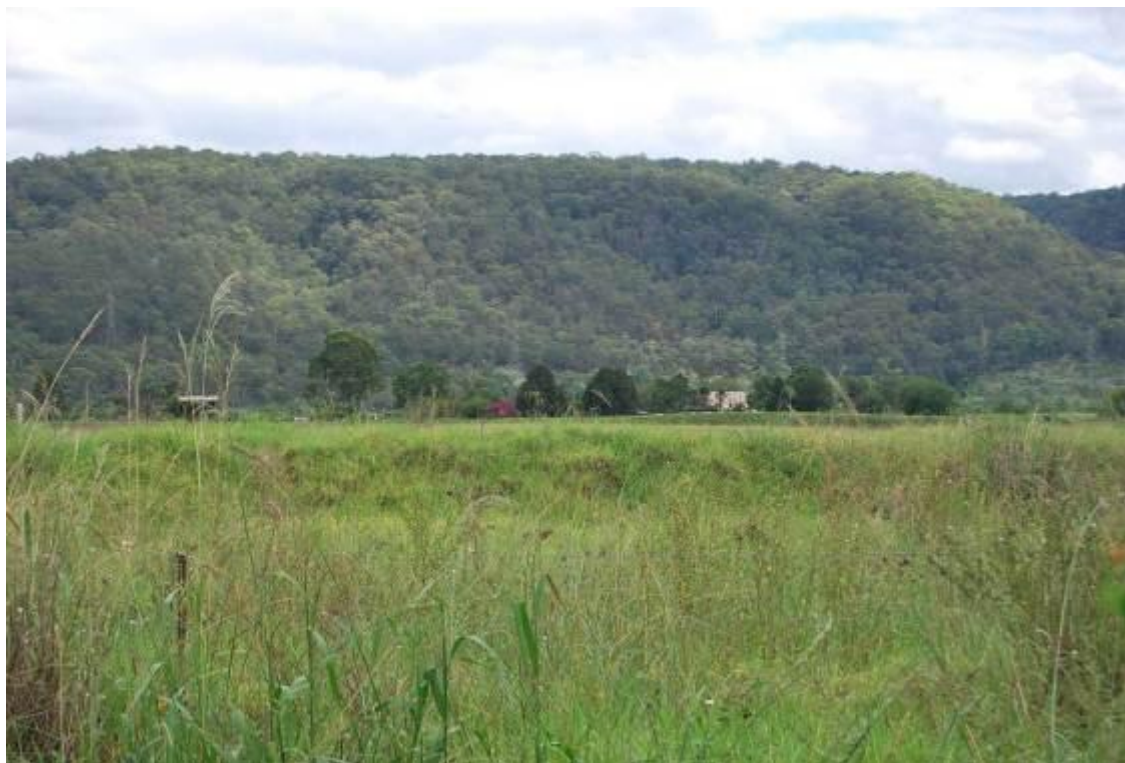
Figure 3.2 2010 photograph of Hadley Park as viewed from the intersection of the former entrance driveway and Old Castlereagh Road shown in the 1978 aerial (see Figure 2.11). This image illustrates the original setting and design intent as a substantial house 'to be seen' from the road. The visual setting of Hadley Park is enhanced by the Blue Mountains escarpment to the west behind Hadley Park. Before the official crossing of the Blue Mountains in 1814, the Nepean and the escarpment represented the edge of the district.

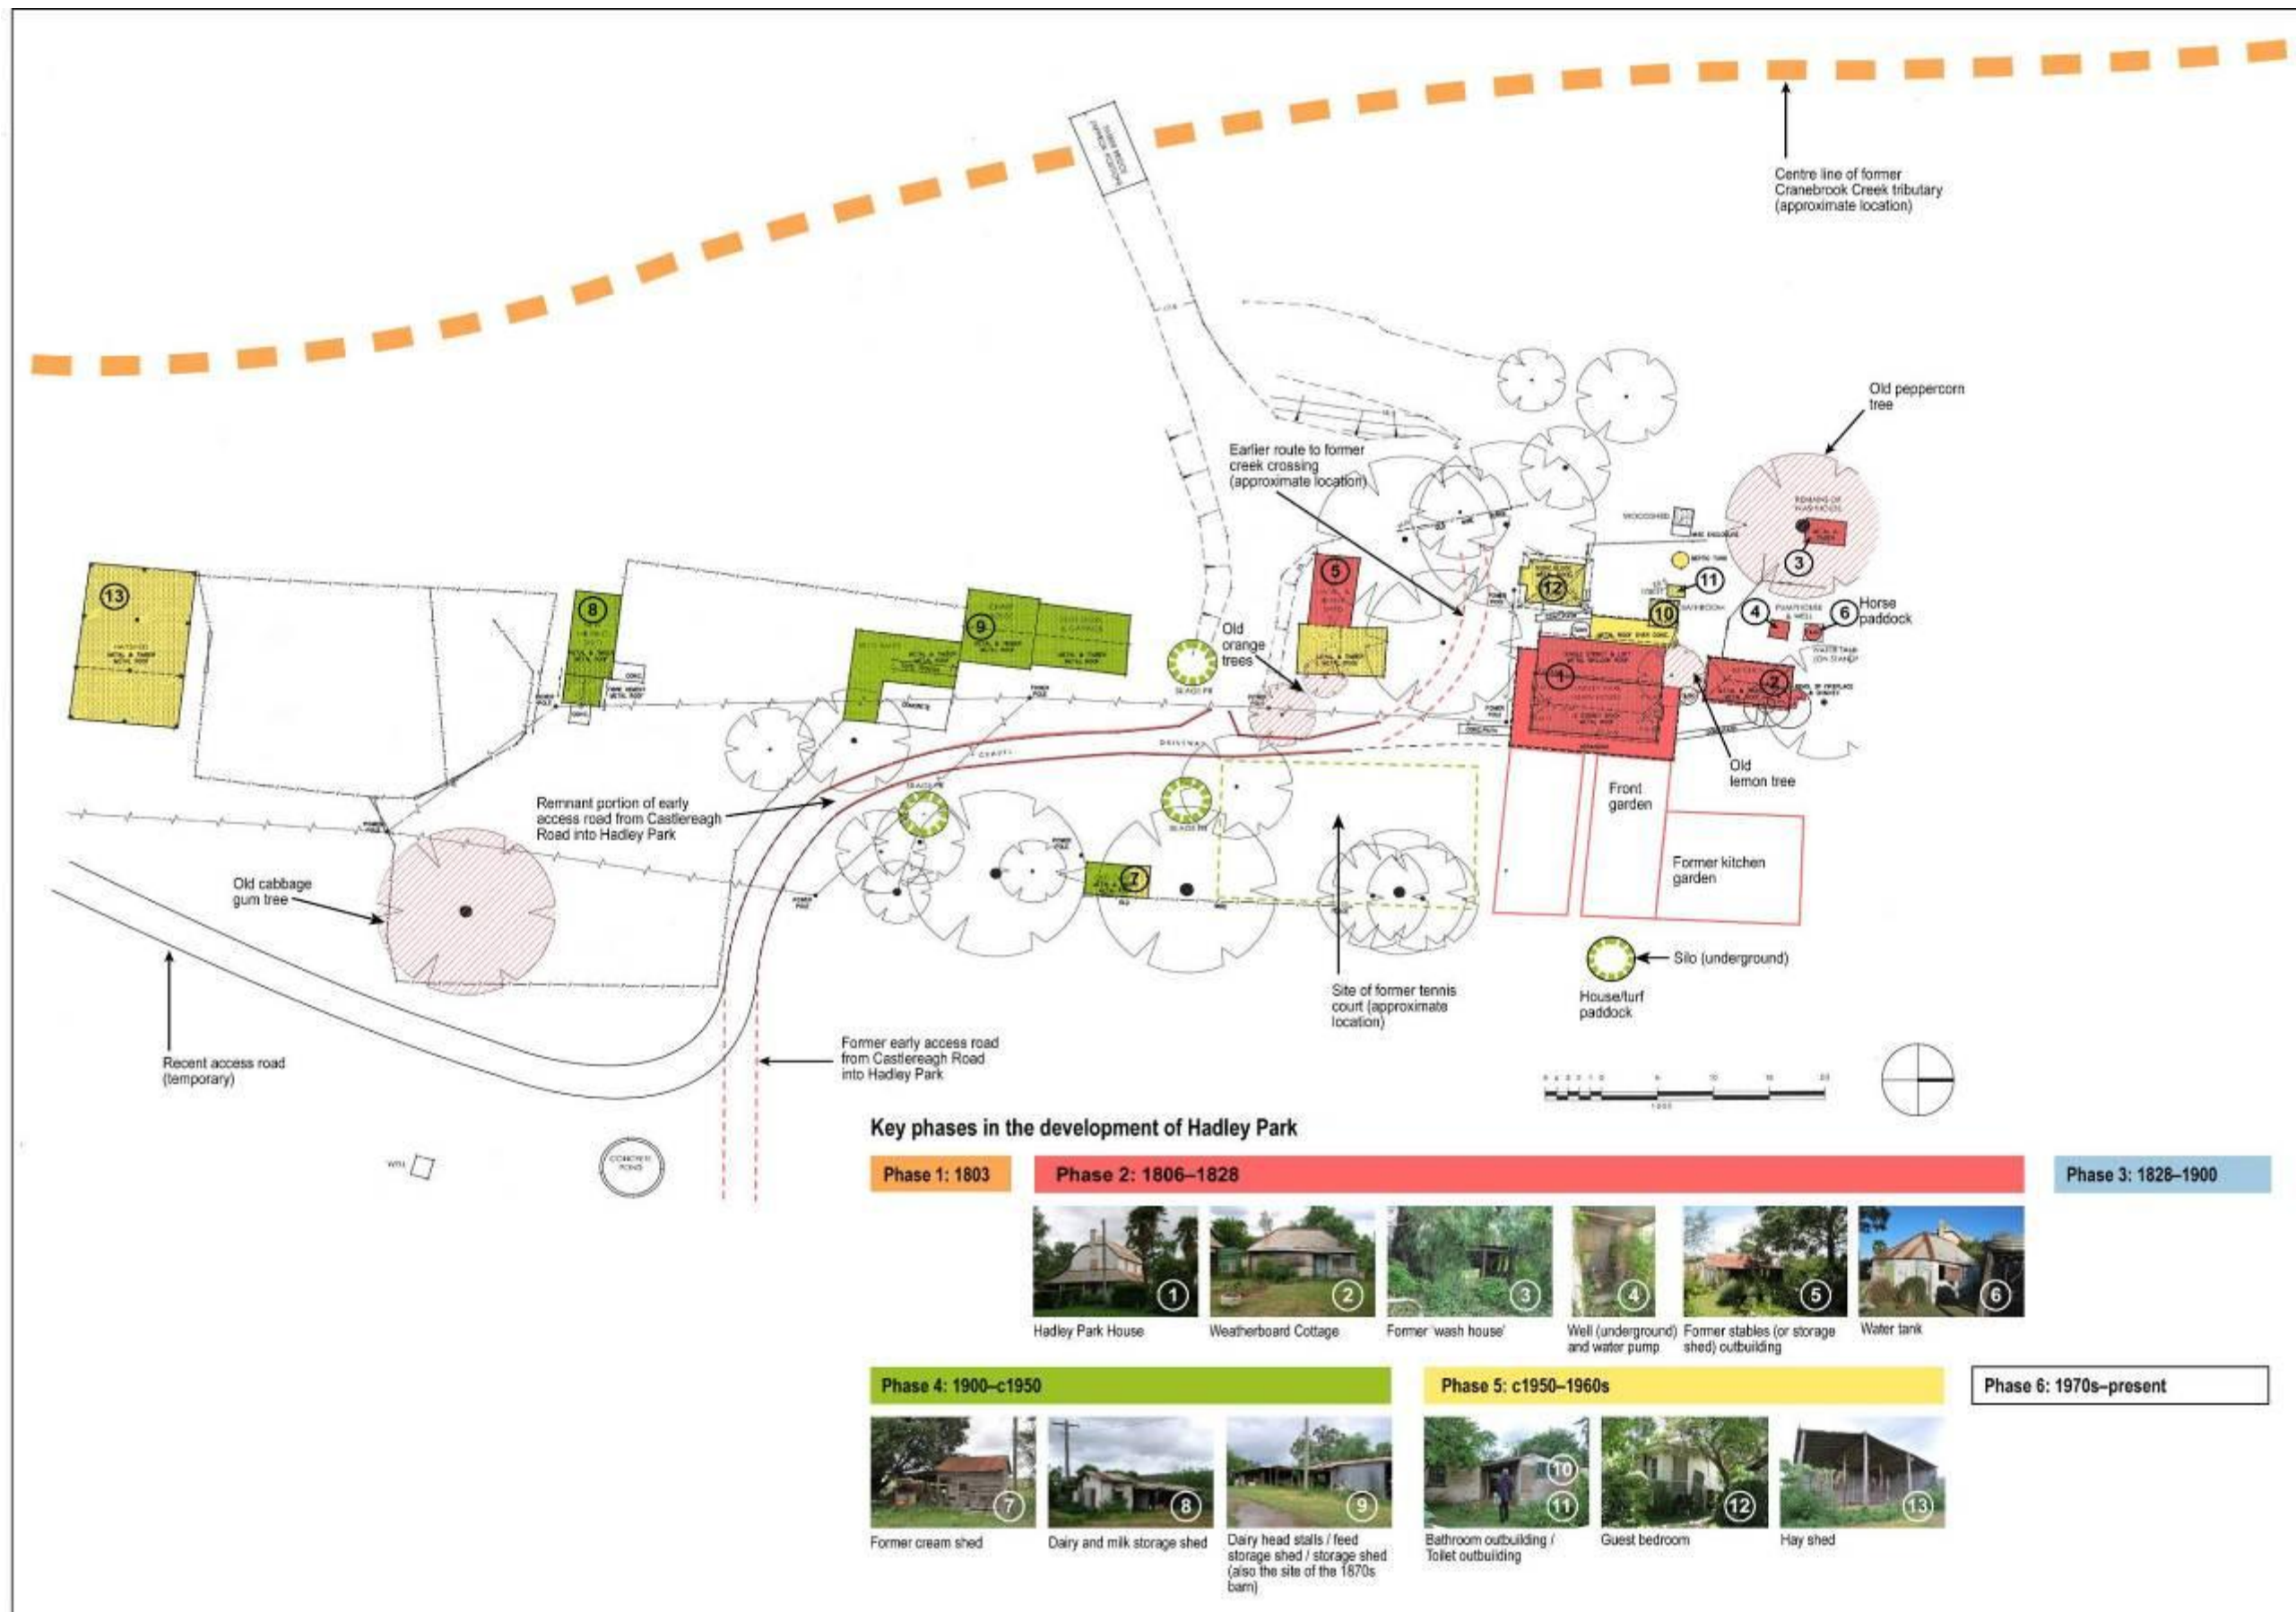
Figure 3.7 Plan showing the key phases of development of Hadley Park and surviving key elements relating to each phase of development. (Source: Base plan provided by Truman, Zaniol and Associates Pty Ltd, edited by GML, 2010)
 Note: The buildings have been numbered to assist with locating them on the plan and to distinguish them throughout the CMP. The numbering of the building does not indicate their specific order of occurrence or level (grading) of significance.

- Phase 1: 1803–1806—original land grants.
- Phase 2: 1806–1828—Hadley Park built by Charles Hadley (Sr).
- Phase 3: 1828–1900—little building development/the floods.
- Phase 4: 1900–c1950—development of dairy farming.
- Phase 5: c1950–1960s—mining use.
- Phase 6: 1970s–present—extensive quarrying and remediation within the Scheme area.

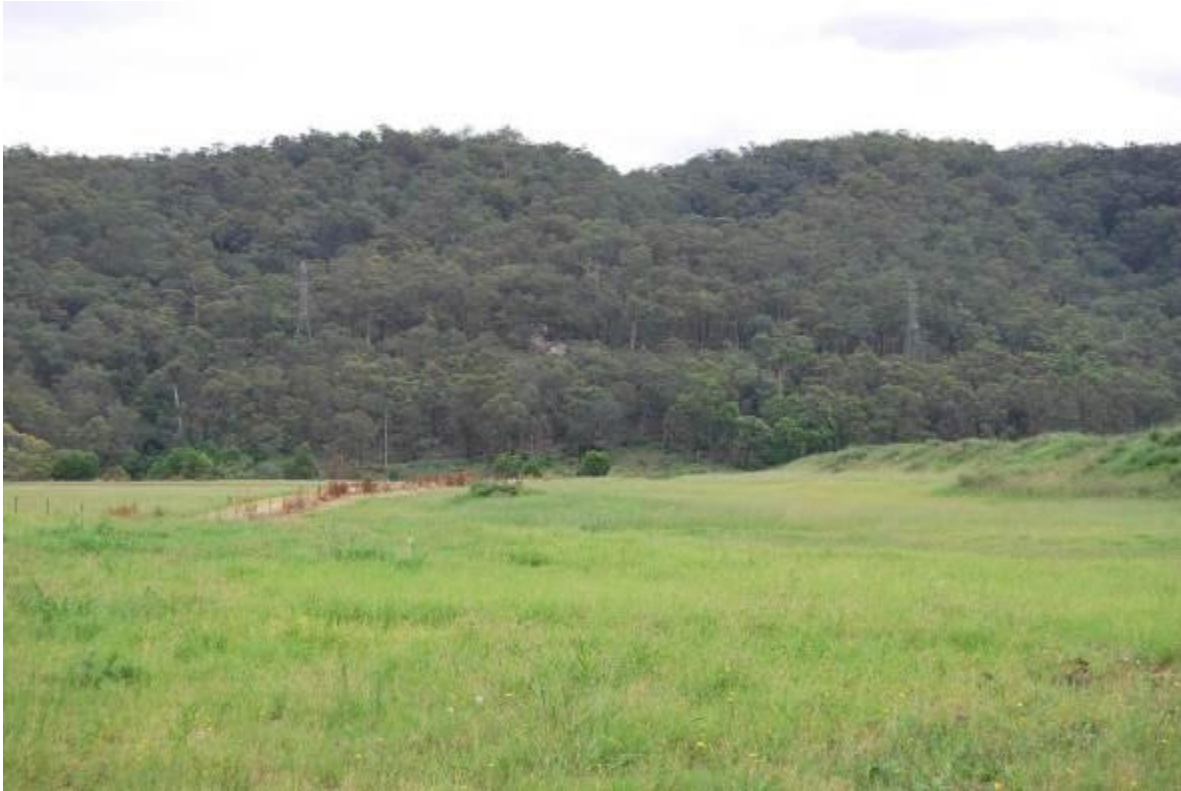
Figure 3.8 2010 photograph showing the fenceline setout of the original (1803) boundary to the south of Hadley Park, adjacent to Nepean Park.

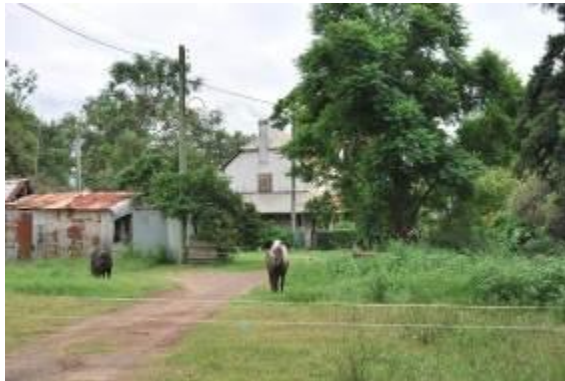
Figure 3.9 Looking north from the existing driveway into Hadley Park, a surviving portion of the early approach from Old Castlereagh Road into Hadley Park (see Figure 3.7).

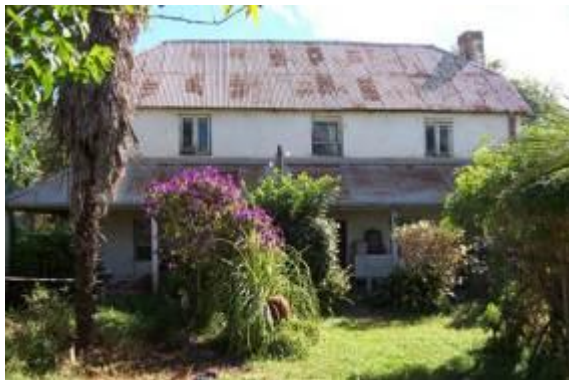
Figure 3.11 Hadley Park House, east elevation, showing the symmetrical facade arrangement, the separate verandah and the front garden with its central entrance pathway to the house. Some form of ornamental bedding may have existed either side of the dividing path.

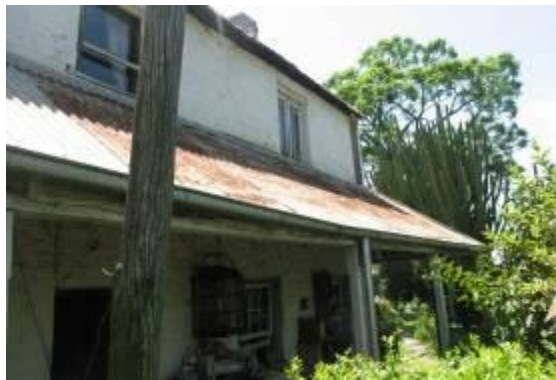
Figure 3.12 Looking north along the front garden showing the east (front) verandah. In the early colony (pre-1820s), verandahs were not common and were found mainly on important buildings or on the houses of important or aspiring settlers. Prior to 1820 houses were introspective and verandahs were not regarded as living space but as a shelter to protect the main (internal) rooms from the weather.

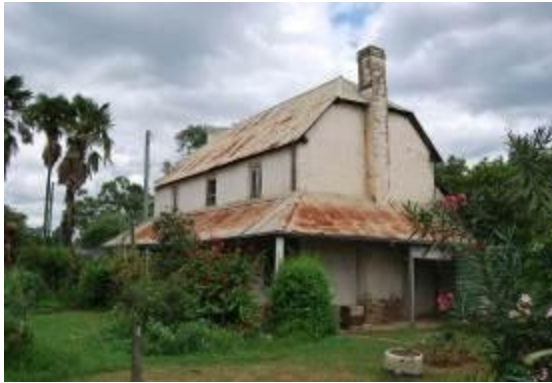
Figure 3.13 Northeast presentation of Hadley Park House showing the jerkin-head gable and wrapping-around verandah.

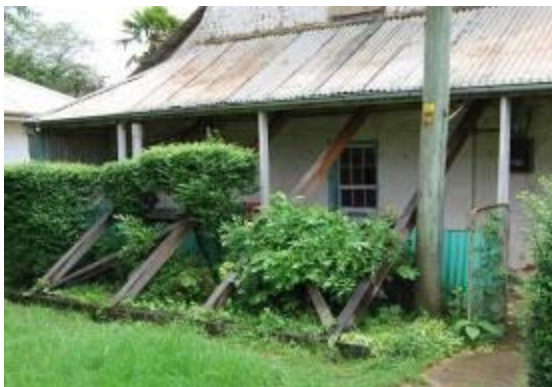
Figure 3.15 South presentation of Hadley Park House showing the privet edging along the verandah. The (temporary) props were introduced in 2008.

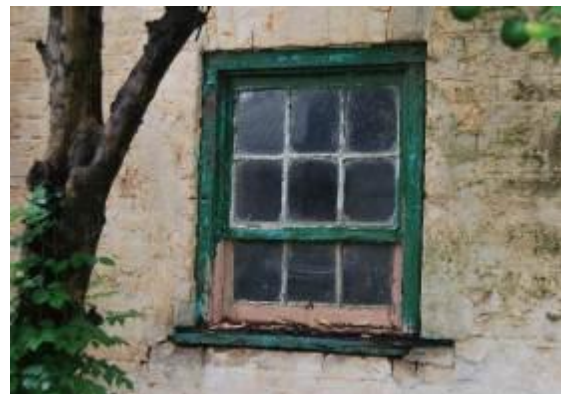
Figure 3.16 Detail of original multi-paned sash window (three small light bottom sash and six light top sash).

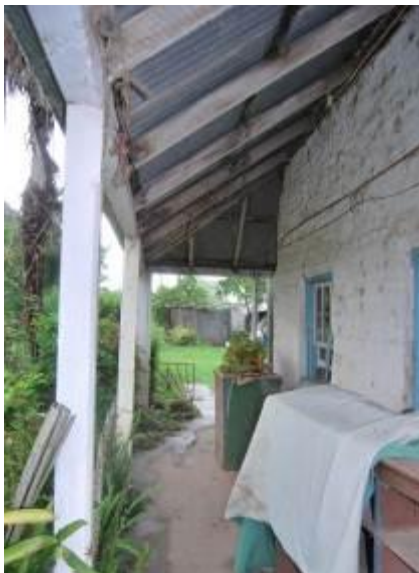
Figure 3.17 Looking south along the east verandah showing original timber chamfered posts and beams, and later rafters and battens supporting the corrugated-iron roof.

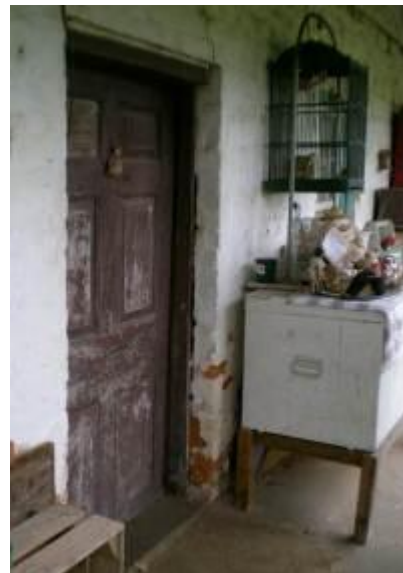
Figure 3.18 Detail of the original, typically solid, six-panelled door. Note the concrete floor (date unknown).

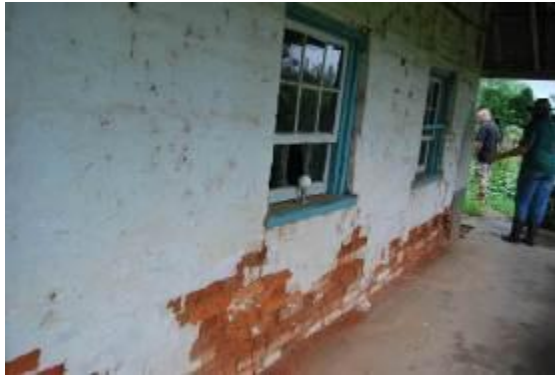
Figure 3.19 Exterior photograph showing the external brick face and limewash finish. While examples of brick nogging construction are common in the Hawkesbury Nepean area (see comparative examples in Section 3.4 below), the walls are typically plastered on the inner face, and feathered weatherboards nailed to the timber uprights on the external face. The external brick cladding at Hadley Park is uncommon.

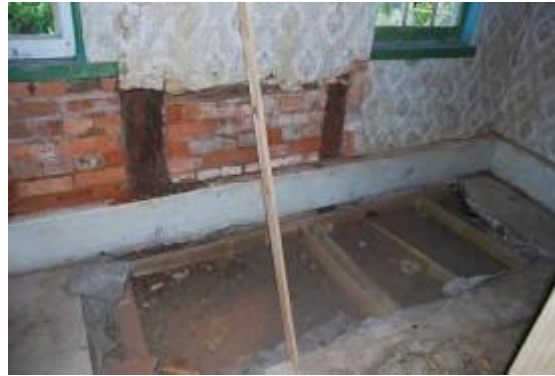
Figure 3.20 Interior photograph showing the original brick nogging construction. The timber uprights provided the structure for walls and openings and were set directly into the ground. The walls are constructed of 230mm solid brickwork (no cavity). The concrete floor and the concrete skirting were introduced in the 1930s.

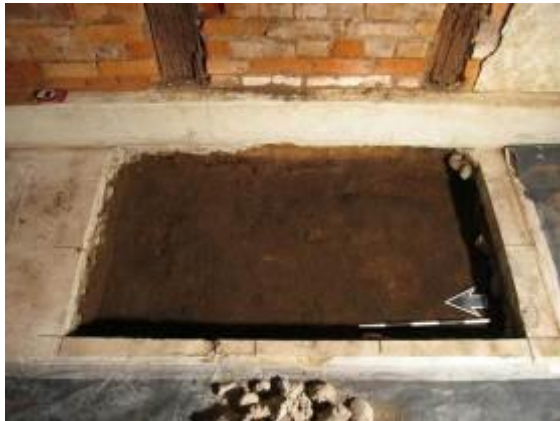
Figure 3.21 Interior photograph showing the location of the surviving timber sole plate. The timber structure has disintegrated into the soil. The floor would have been timber boards.

Physical investigation undertaken in 2008 revealed evidence of a timber bearer and timber sole plate below the first course of bricks of the eastern wall in bedroom 1 and a sandstock brick floor in the dining room and store room within the rear (skillion-roofed) portion of the house (see Figures 3.21 and 3.22).

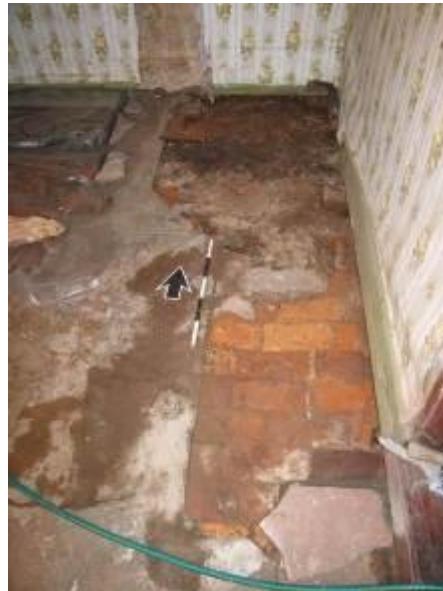
Figure 3.22 Interior photograph showing detail of the surviving sandstock brick floor in the dining room within the skillion-roofed portion to the rear of Hadley Park House.

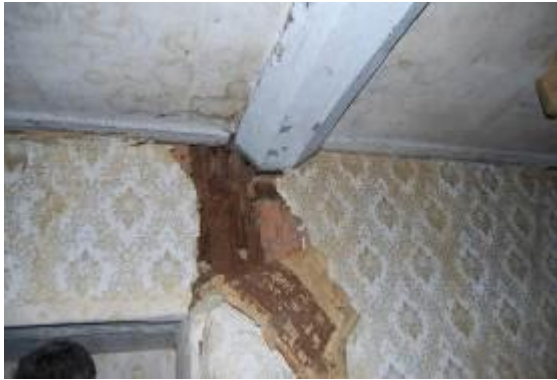
Figure 3.23 Interior photograph showing detail of the original timber post and chamfered beam at the junction, with later wallpaper covering.

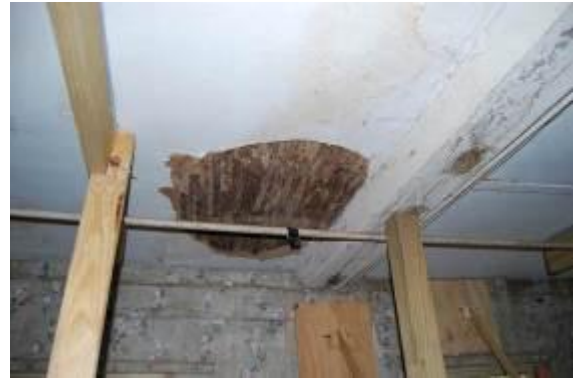
Figure 3.24 Interior photograph showing detail of the original lath and plaster ceiling and exposed timber chamfered beams. Note the (temporary) props were introduced in 2008.

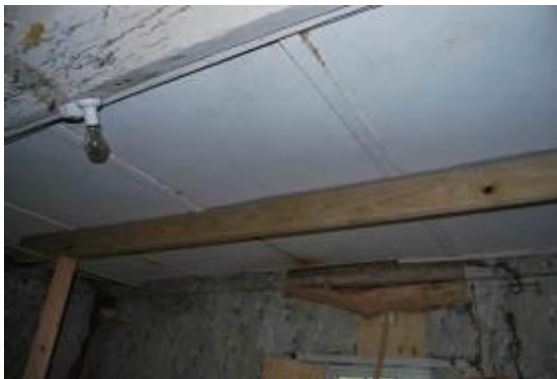
Figure 3.25 Interior photograph showing a later asbestos sheet ceiling and the recent 2008 propping.

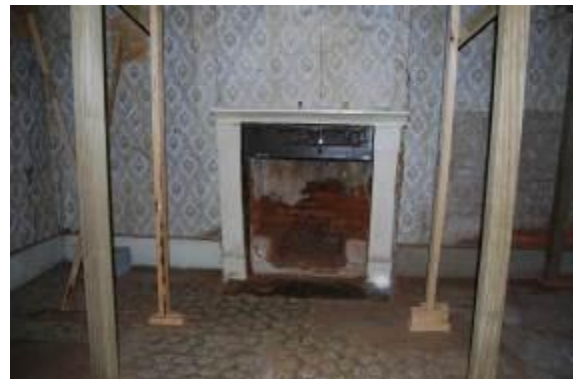
Figure 3.26 Interior photograph showing the original fireplace on the north elevation of Hadley Park House.

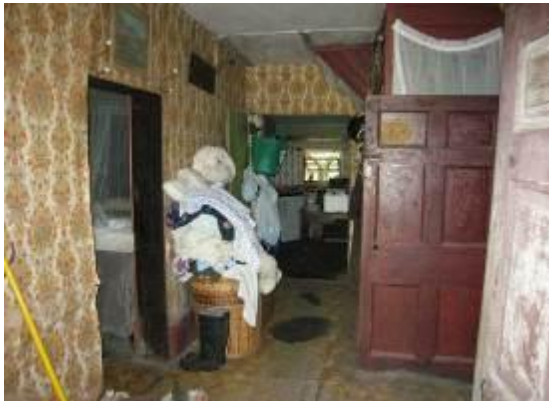
Figure 3.27 Internal view of the entrance hall (ground floor) showing the original internal solid six-panelled door and the stair leading to the first floor.

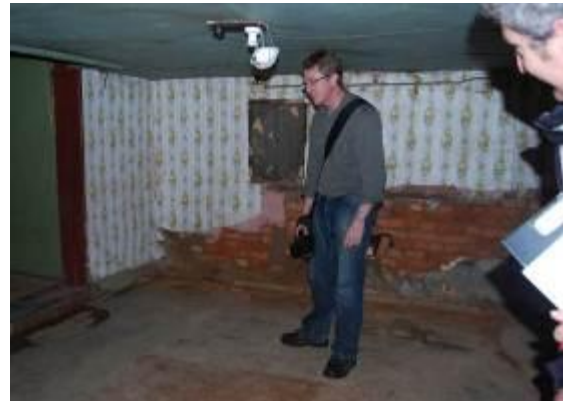
Figure 3.28 Interior photograph illustrating the (typically) low ceilings.

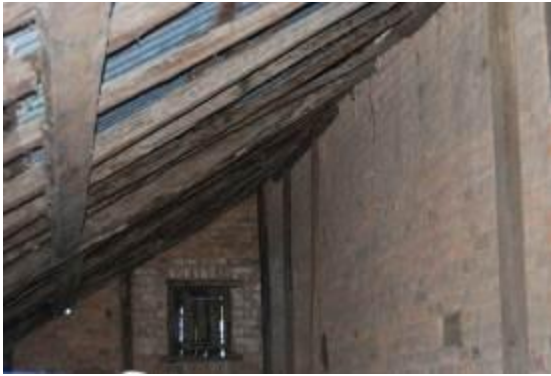
Figure 3.29 Interior photograph showing the skillion roof to the rear of Hadley Park House. Note the use of split timbers and battens for shingles.

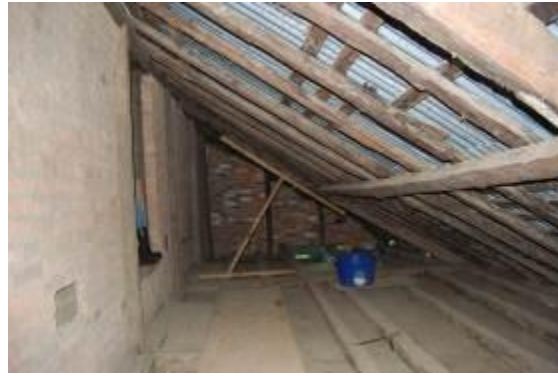
Figure 3.30 Interior photograph of the attic space to the rear of Hadley Park House, possibly built as a storage area above the potential flood waters. Note the access opening on the western wall off the stairwell.
