Hadley Park

Conservation Management Plan

Revised Report

Report prepared for Penrith Lakes Development Corporation
September 2013

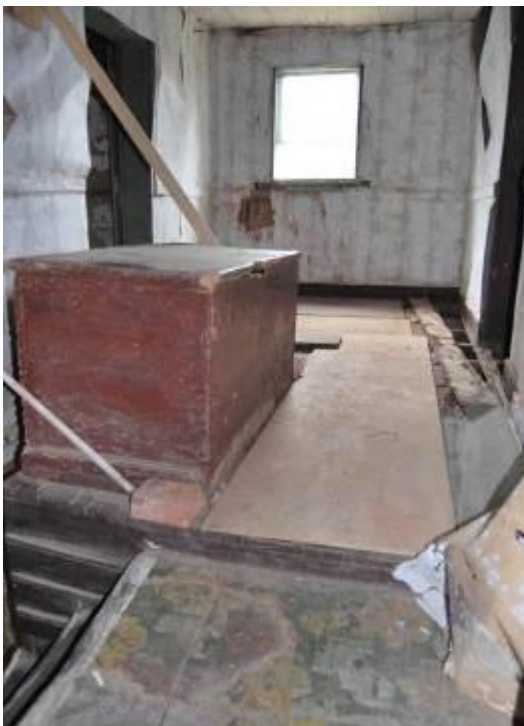
Figure 3.31 Interior photograph of the first floor showing original internal joinery and stairwell hall.

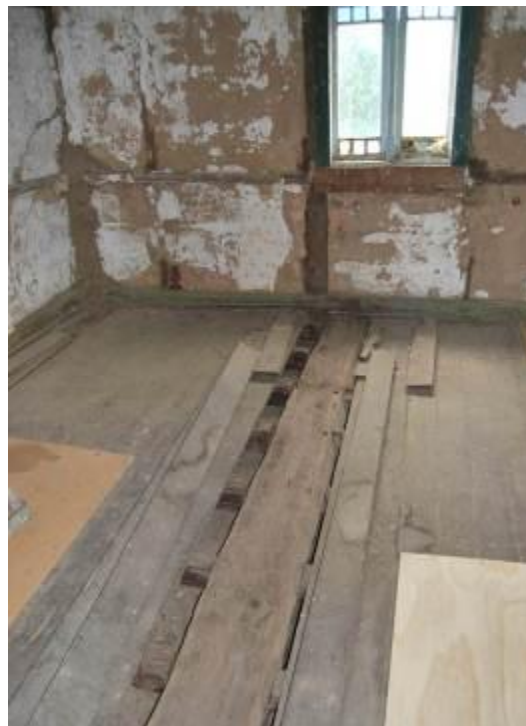
Figure 3.32 Interior view of the first floor, showing the original timber beaded skirting and chair rail and evidence of limewash finish. The timber floorboards and joists are supported on timber beams which bear onto the brickwork. Note the original opening fitted with a later window (see Figures 2.3 and 2.6).

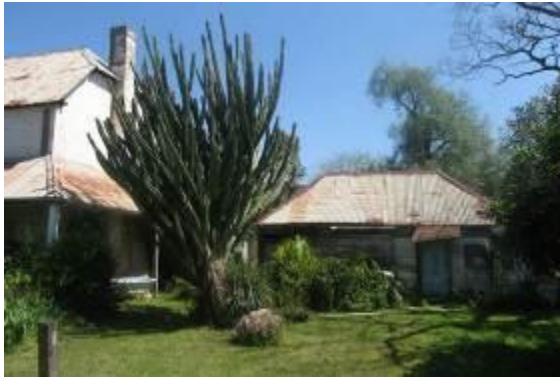
Figure 3.35 East presentation of the Weatherboard Cottage. Hadley Park House to the left.

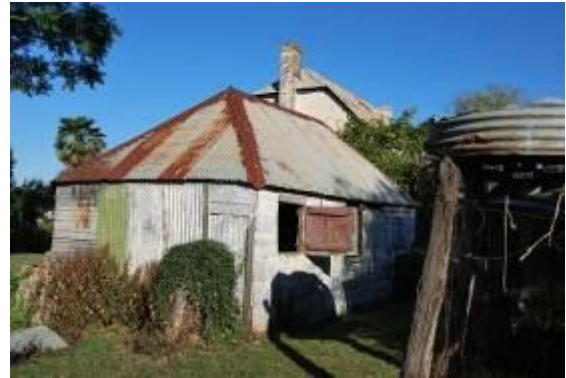
Figure 3.36 North presentation of the Weatherboard Cottage with Hadley Park House in the background. Note the original window openings fitted with tin shutters (hinged) and tin sheet walling (unknown date) on the west elevation. The elevated water tank is supported by four circular bush poles, sawn timber beams and a platform consisting of sawn planks.

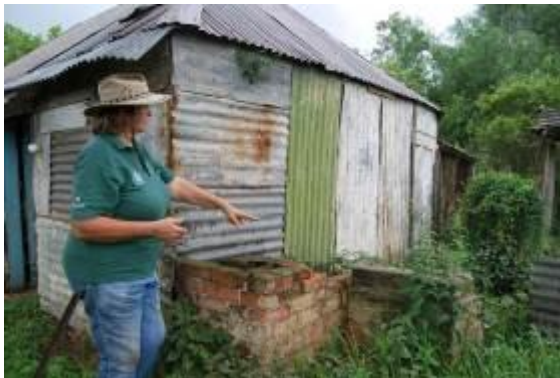
Figure 3.37 Detail of the north elevation showing the remains of the external fireplace (used for cooking) built of incombustible materials unlike the adjoining structure (typical of cottage construction). Jacqueline Flower, descendant and tenant of Hadley Park to the left.

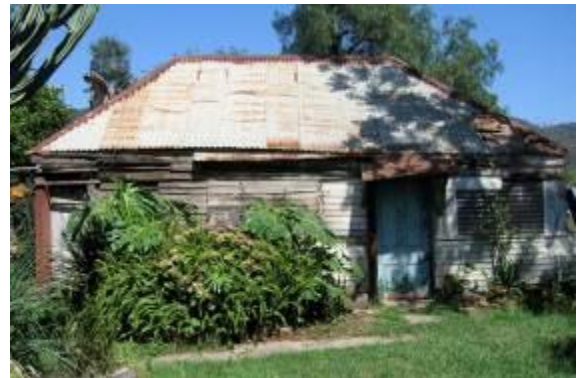
Figure 3.38 East elevation. The replacement of original weatherboards with horizontal timber boarding, corrugated-iron sheets, and the recycled panelled door and tin sheet awning illustrate the use of replacement fabric as available.

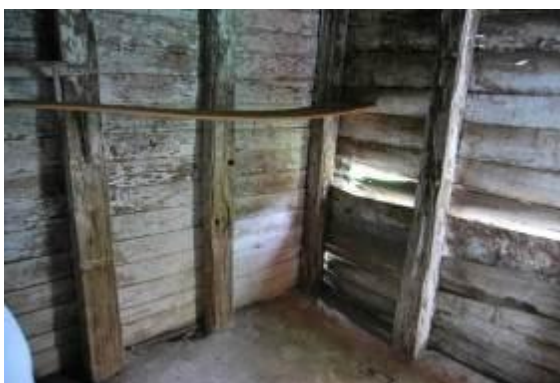
Figure 3.39 Interior photograph showing the original split timbers lined with weatherboards forming the south and east walls of the cottage.

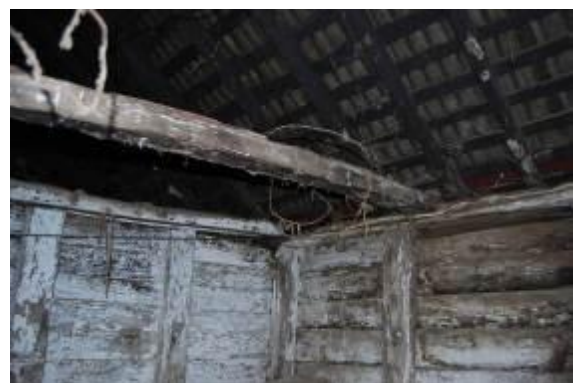
Figure 3.40 Interior photograph showing the split timbers and battens for shingles.

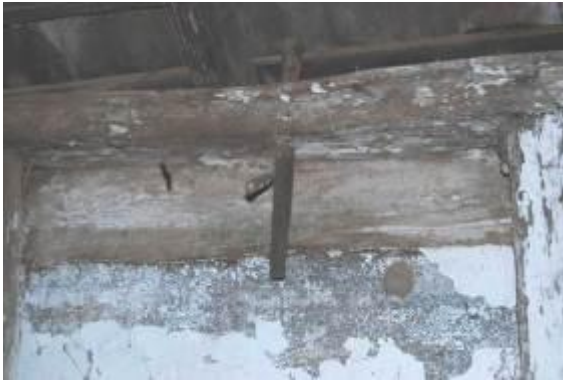
Figure 3.41 Detail of pegged (timber) joint. Note original weatherboards and replacement with tin sheeting (unknown date) below.

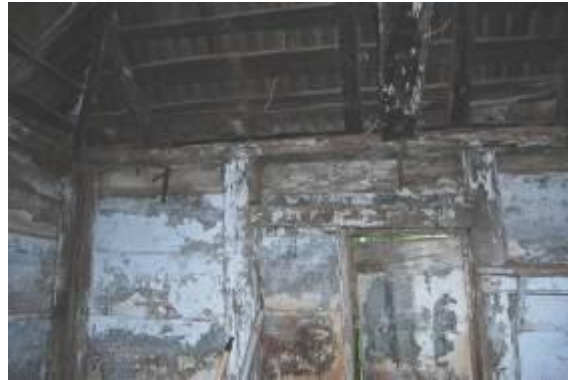
Figure 3.42 Detail of the internal wall (west elevation) showing the original structure forming the opening and original weatherboards (upper section). Note lower walling replaced with tin sheets (unknown date).

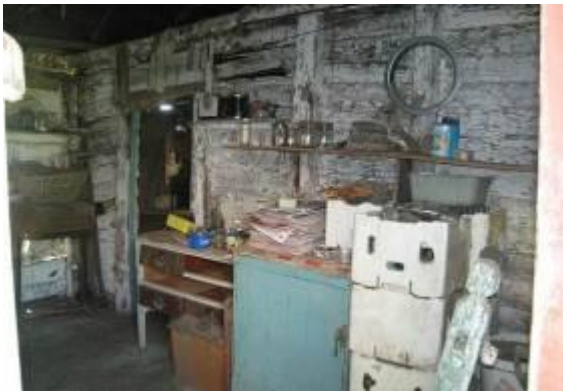
Figure 3.43 Interior view of the Weatherboard Cottage showing the partition wall between the two rooms.

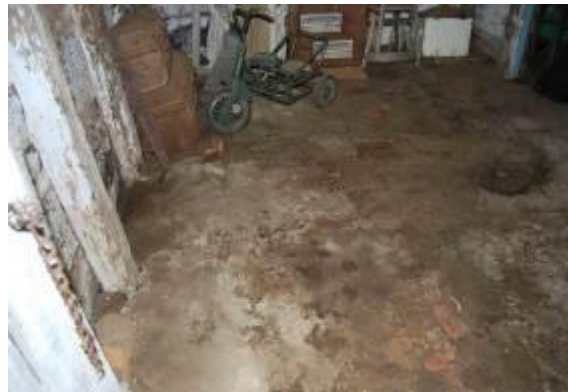
Figure 3.44 Interior detail of the Weatherboard Cottage showing the sandstock brick floor with cement covering.

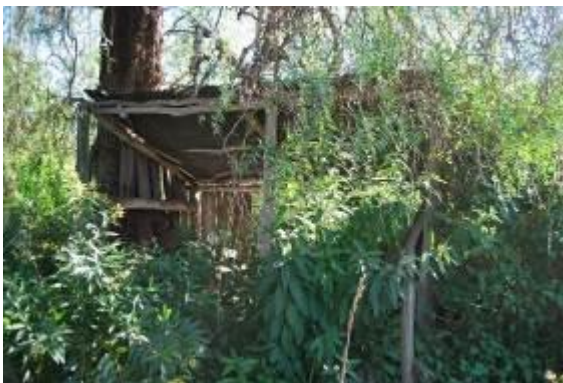
Figure 3.45 Site of the former 'wash house'. Note the use of recycled vertical timber slabs.

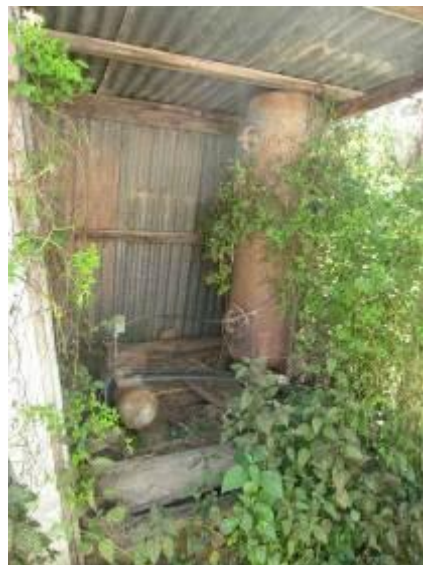
Figure 3.46 The well (covered with timber slabs) and the later shed.

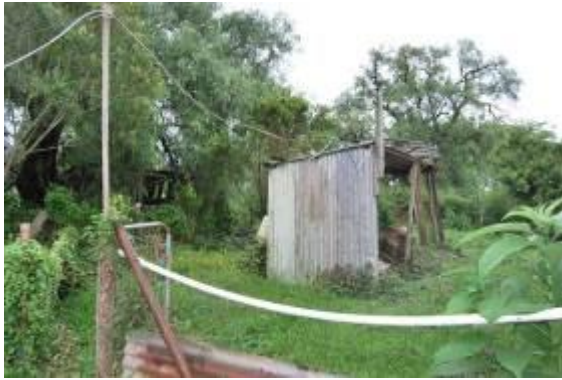
Figure 3.47 The brick well and water pump (to the right), the site of the former 'wash house' (to the left) and the septic tank (to the north) illustrate the availability of services and living conditions. The shed is a twentieth-century addition, probably introduced at the time of the adaptation of the water pump to electrical power.

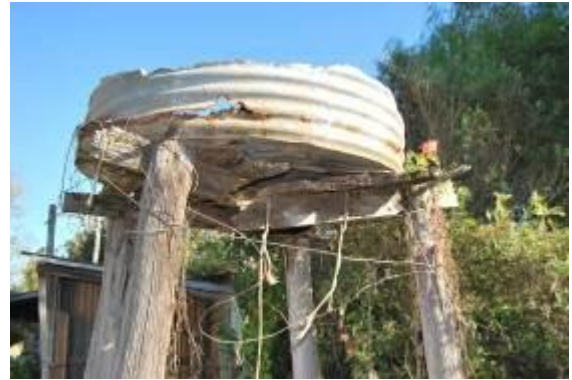
Figure 3.48 The water tank is a circular corrugated-iron tank supported by four circular bush poles, sawn timber beams and a platform consisting of sawn planks.

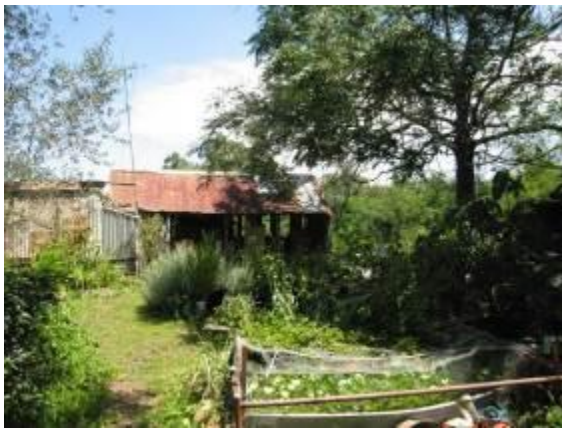
Figure 3.49 North presentation of the original portion of the former stables (or storage shed) outbuilding. Note the line of trees to the west to protect the buildings from the winds.

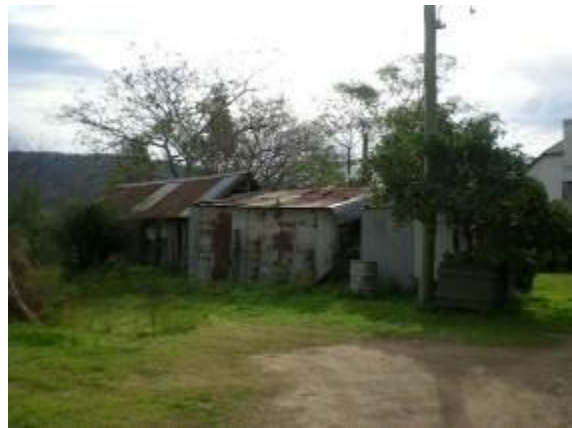
Figure 3.50 South presentation of the former stables (or storage shed) outbuilding showing the original portion (to the left) and the 1950s–1960s addition (to the right).

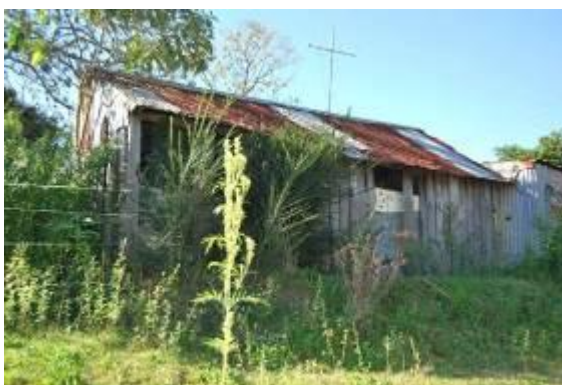
Figure 3.51 South presentation of the original portion of the former stables (or storage shed) outbuilding showing original vertical timber slab construction.

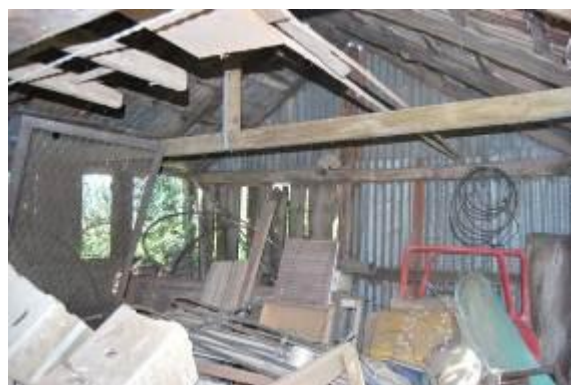
Figure 3.52 Interior view of the original portion of the former stables (or storage shed) outbuilding showing original timber slab construction and replacement with corrugated-iron sheets.

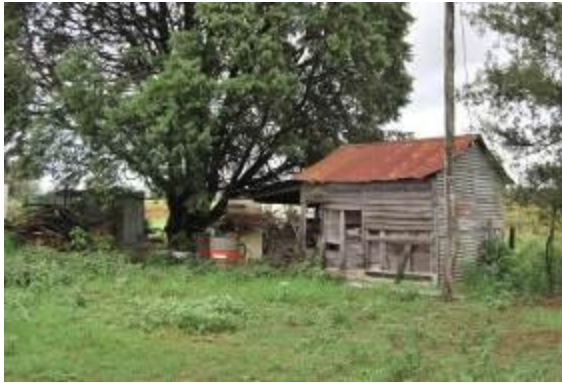
Figure 3.53 Exterior photograph of the former cream shed. Note the extension to the north for use as a workshop.

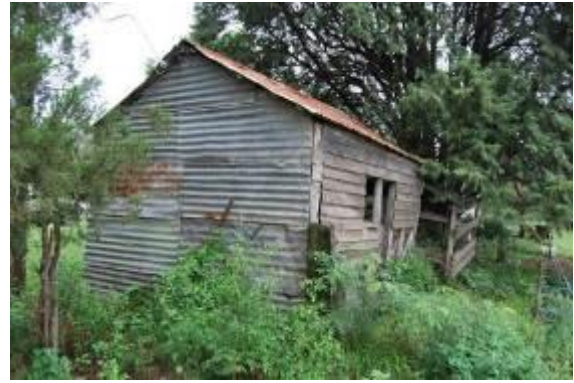
Figure 3.54 Exterior photograph of the former cream shed showing the replacement corrugated-iron sheet wall and the 1950s–1960s extension to the north.

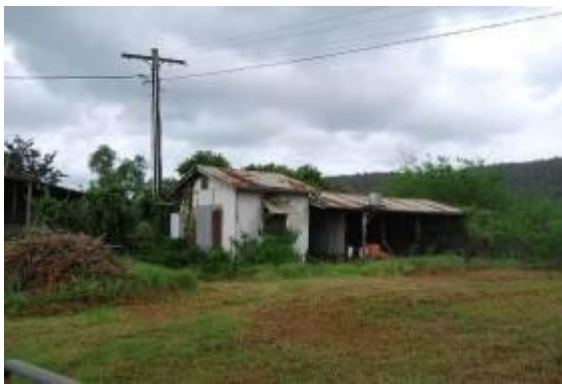
Figure 3.55 The milk storage shed (to the left) and milking stalls (to the right).

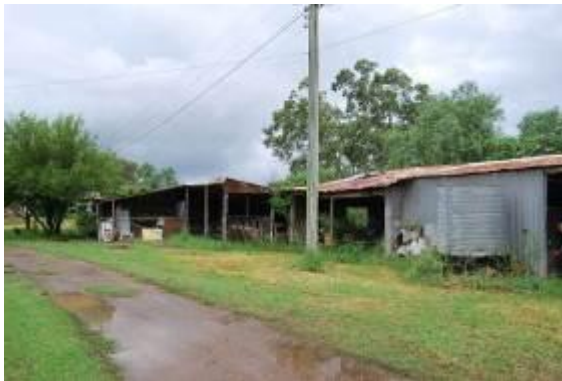
Figure 3.57 Exterior view of the dairy head stalls, feed storage shed and storage shed, looking south along the early access road from Old Castlereagh Road into Hadley Park.

The dairy head stalls (south portion), feed storage shed (middle portion) and storage shed (north portion) are a typical early-twentieth-century dairy timber-framed construction. One row of the dairy feed stalls, including the roof above, was demolished in c1950s–1960s.

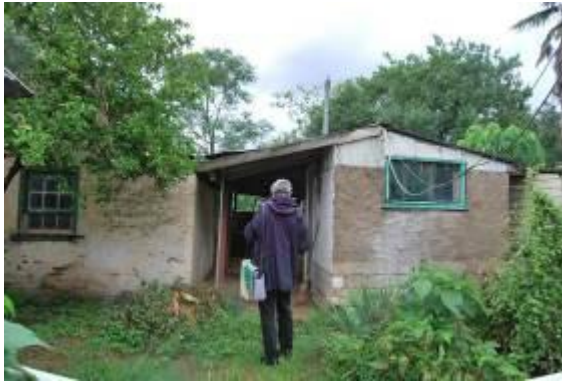
Figure 3.58 North presentation of the external bathroom showing the covered walkway and Hadley Park House to the left.

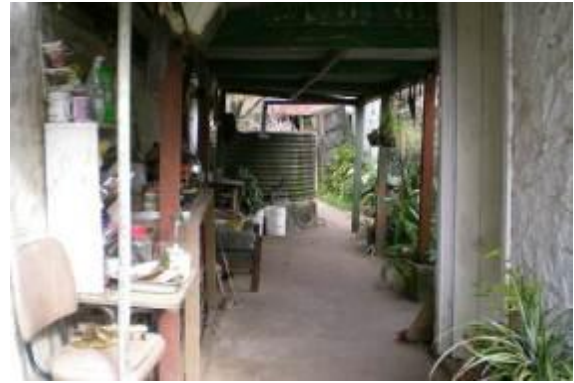
Figure 3.59 Interior view, looking south along the covered walkway connecting Hadley Park House (to the left) and the external bathroom and toilet (to the right).

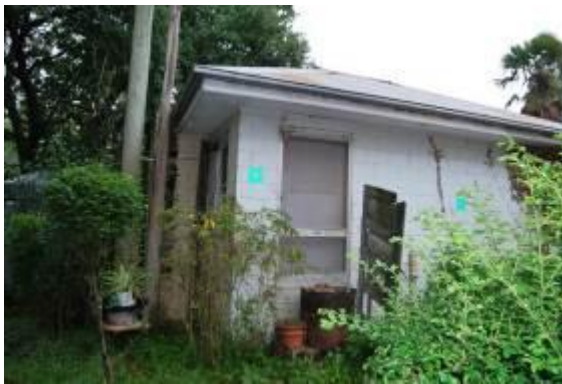
Figure 3.60 North presentation of the guest bedroom, originally built as a kitchen but never used for this purpose.

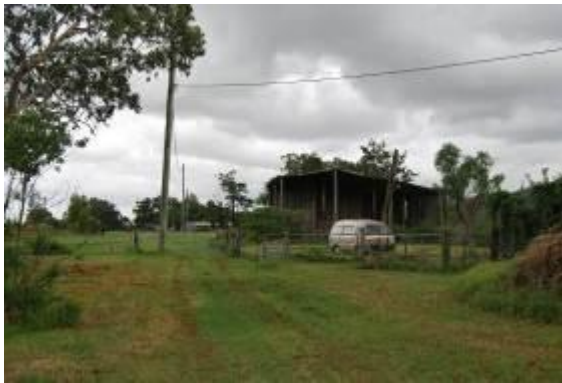
Figure 3.62 The hay shed and its immediate context to the south of Hadley Park, adjacent to Nepean Park.

The hay shed is a substantial, tall, post and beam construction, built of bush poles sometime between 1947 and 1961. The hay shed is rectangular in plan, comprising three bays, and has a gabled roof clad in corrugated iron. The south and west walls are also clad in corrugated iron. It is well removed from Hadley Park House (see Figure 3.2). The hay shed has been used for the storage of hay and farm machinery (see Figure 3.63).

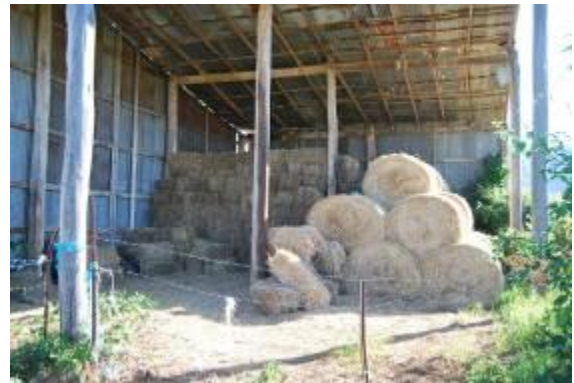
Figure 3.63 Interior view of the hay shed.

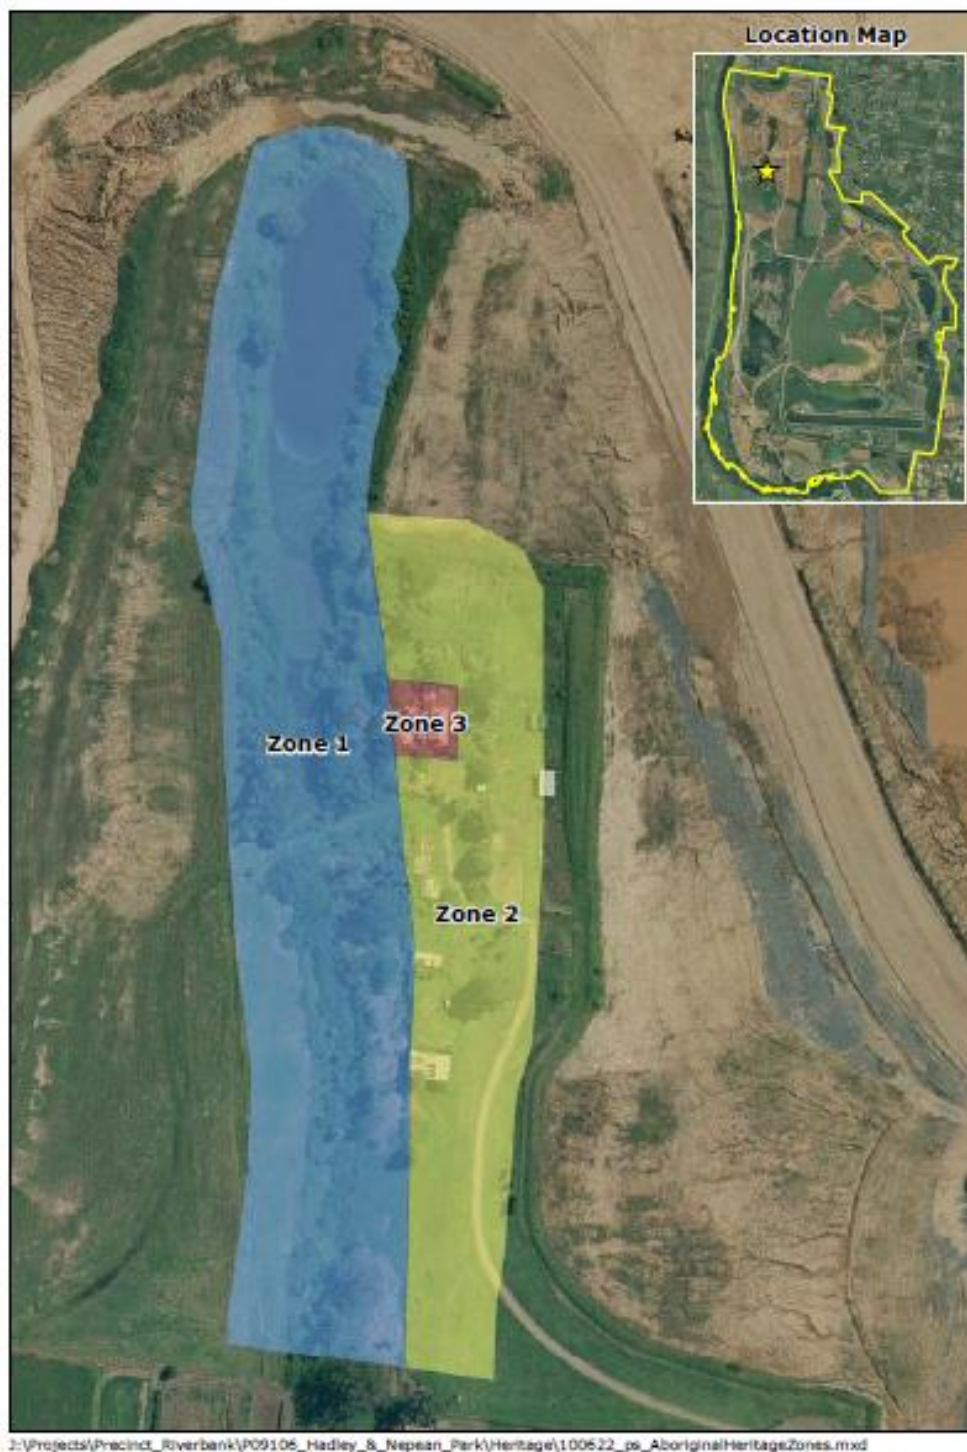
Figure 3.76 Hadley Park Aboriginal Cultural Heritage Zones. Zone 1 is Cranebrook Creek tributary, Zone 2 is Hadley Park, Zone 3 is Hadley Park Homestead. (Source: Muru Cultural Heritage Services).

For the purposes of this report, Hadley Park landscape has been divided into three Aboriginal cultural heritage zones. These are described below and shown in Figure 3.76.

Aboriginal Cultural Heritage Zone	Summary Description	Identified Values
Zone 1—Cranebrook Creek Tributary	Comprises the remnant of Cranebrook Creek tributary and the associated creek banks. It has been identified that there is a high potential for Aboriginal sites to exist within 200m of the Cranebrook Creek area. The area also has a value as it is one of only 3 remnant sections of this creek and offers significant interpretative potential	Potential for Aboriginal Sites. Remnant Section of Cranebrook Creek tributary.
Zone 2—Hadley Park	This section is the balance of the Hadley Park conservation area and has the general potential for Aboriginal Sites.	Potential for Aboriginal Sites.
Zone 3—Hadley Park Homestead	As part of building stabilisation works, several potential Aboriginal artefacts were identified in a series of test pits within and around the house. The artefacts identified and recovered from the Historical archaeological work were found in varying contexts but all within disturbed layers. These layers were introduced fill, levelling fill, and disturbed natural A horizons. The artefacts found in this context are of little scientific value given the disturbed nature and uncertain origin of fills but the artefacts hold value to the local Aboriginal Community.	Potential for Aboriginal Sites.

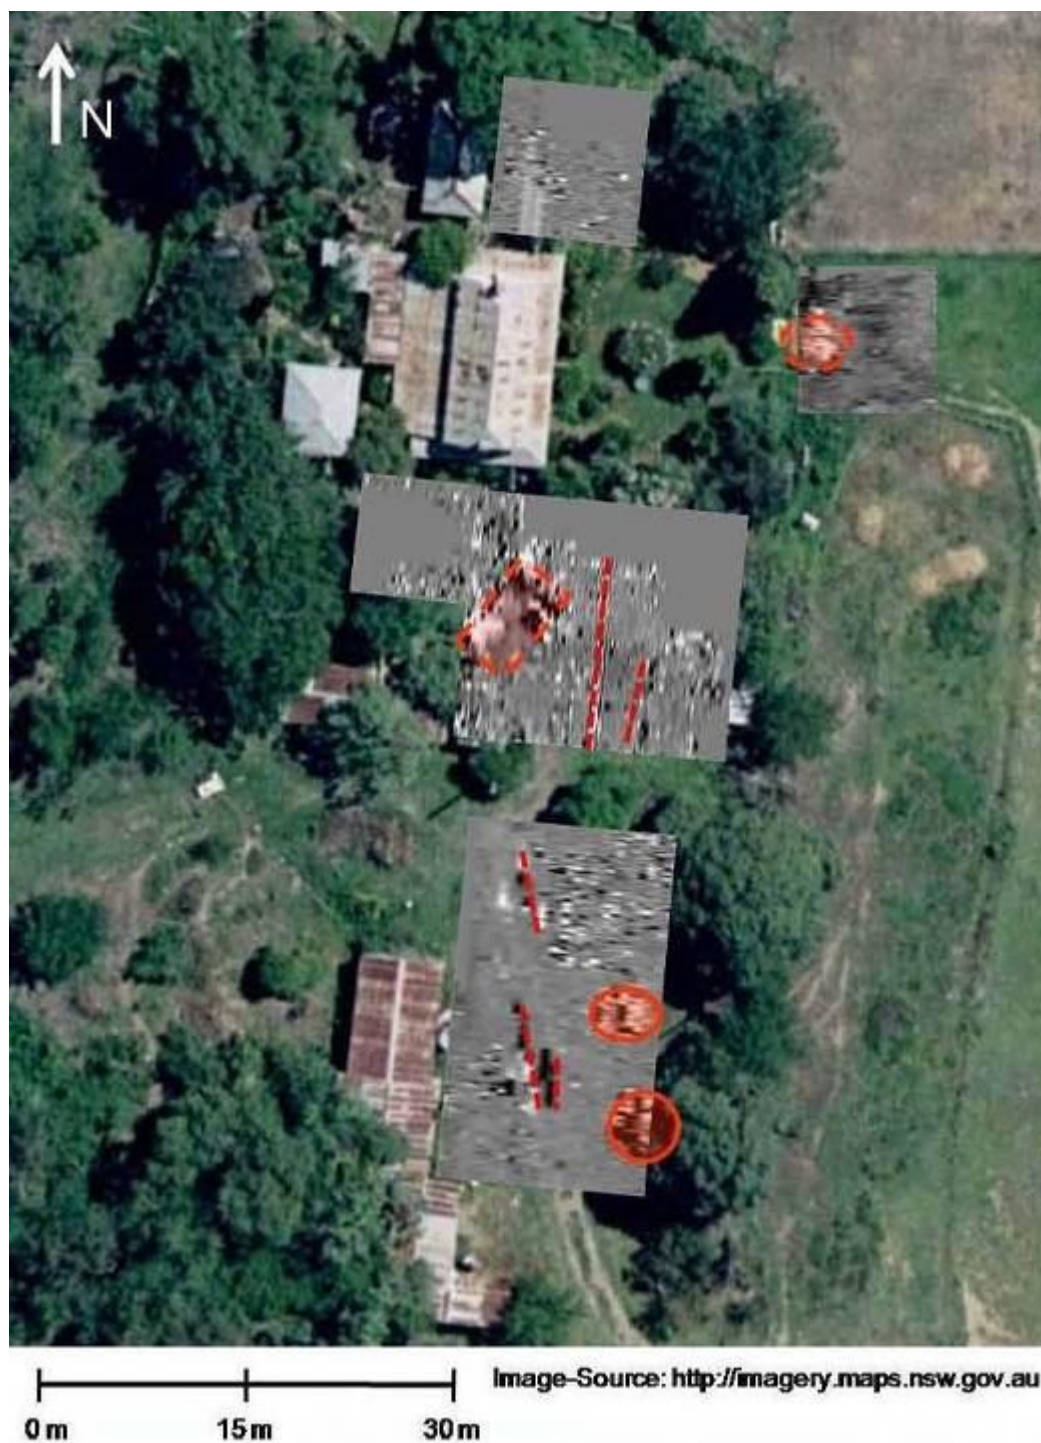
Figure 3.77 Ground penetrating radar image showing the location of a former structure (dashed rectangle), possibly the remains of the former cream shed (previously located closer to the road), underground silos (circles) and services (dashed lines). (Source: Archaeological Computing Laboratory, University of Sydney, 2008)

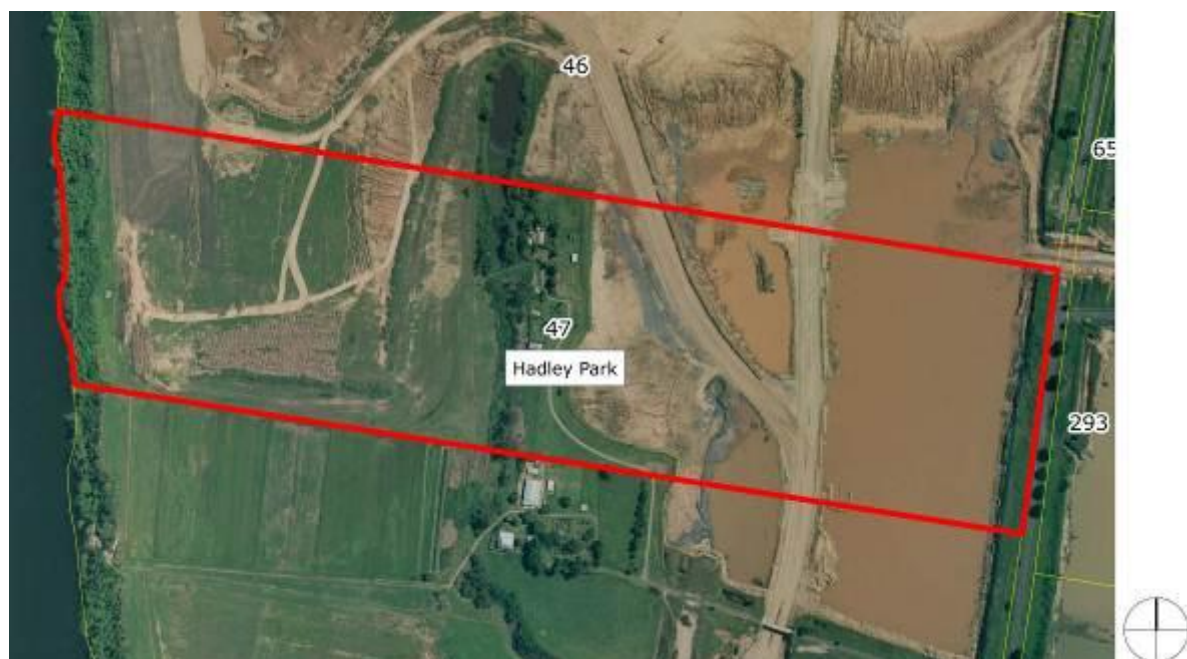
Figure 4.1 2010 aerial showing the original 1803 historical allotment. (Source: PLDC, edited by GML)

Hadley Park, like its neighbour Nepean Park, is located on the original land grant made in 1803 (portion 47) as shown in Figure 4.1 below. The allotment has links with the Nepean River and the alignment of (Old) Castlereagh Road which served as the original boundaries to the west and east respectively. The site also retains evidence of the fence alignment along the southern boundary, adjacent to Nepean Park.

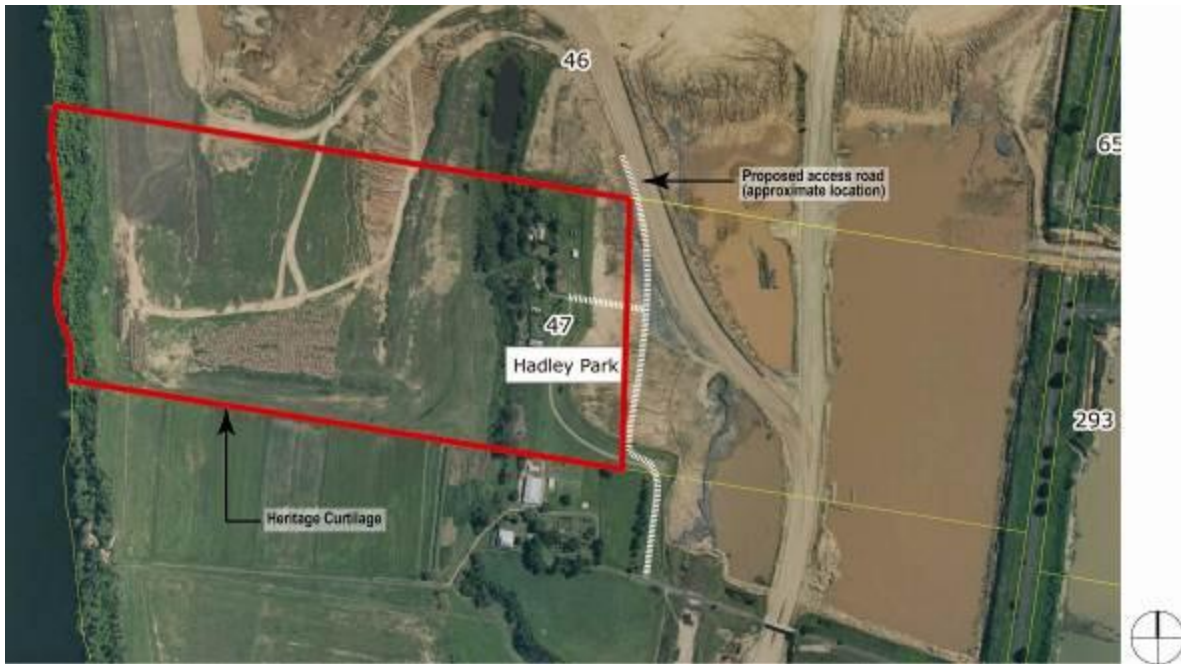
Figure 4.3 2010 aerial showing the area surrounding Hadley Park (heritage curtilage) which is essential for retaining and interpreting the heritage significance of Hadley Park. (Source: PLDC, edited by GML)

As it is not practical to retain the whole of Hadley Park's original land grant area, due to a substantial portion being inundated by the proposed new lake, a reduced heritage curtilage has been considered. A composite heritage curtilage that combines both the properties of Hadley Park and Nepean Park could be considered, but is beyond the scope of this report as the properties are in separate ownerships. The two properties together comprise the most intact remnants of the early Castlereagh subdivision and both retain their early agricultural setting. The heritage curtilage shown in Figure 4.3 below provides for the retention of the key historic relationships between the Hadley Park farm complex and the Nepean river and sufficient land to provide an appropriate and useful agricultural setting for the group. This heritage curtilage is bordered on the north, south and west by the original 1803 grant boundaries as far as the Nepean River, with the eastern boundary just to

the west of the proposed road east of Hadley Park. The proposed heritage curtilage will also allow for the early entry drive into Hadley Park to be re-established off the proposed access road to the east of the farm group. The broader setting of both Hadley Park and Nepean Park beyond the heritage curtilage includes the key views described in Section 3.1 of this CMP, the overall landscape including remnant indigenous plantings, and interpretation of the historic allotment boundaries and related places which give historical and social context to both Hadley Park and Nepean Park.

If listing of Hadley Park should proceed it would seem reasonable that the listed area be the same as the recommended heritage curtilage in Section 4.5.3 and Figure 4.3 of this CMP, being lands within the 1803 grant boundary to the west of the new proposed road alongside the main lake as far as the Nepean River.

Policy 27—The heritage curtilage defined in this CMP (see Figures 4.3 and 6.1) should be retained as the minimum area required to conserve the heritage significance of Hadley Park. Subdivision of the heritage curtilage should not occur.

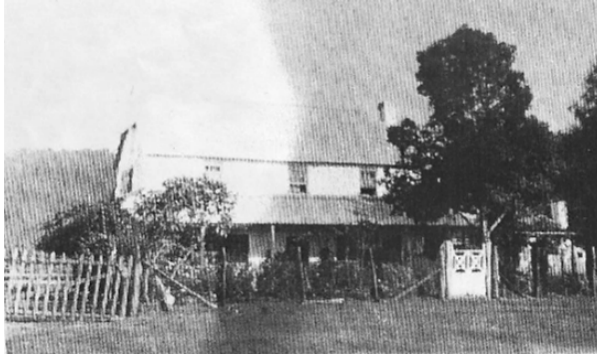
2.1.1 Undated Photograph (c.1900)

This is the earliest available photography and probably dates to the turn of the century. Notable elements evident in the photograph are the ornamental gate separating the front garden from the front paddock, the picketted farm gate at left, the unidentified tree near the gate, the extensive shrubbery within the front garden and the clear view behind the house to the Lapstone Monocline beyond.

At the extreme right side of the photograph the forms of taller trees are evident suggesting either the retention of indigenous tree species or, more likely, the maturing of much earlier plantings. The planted front garden contrasts markedly with the front paddock which is kept as a field.

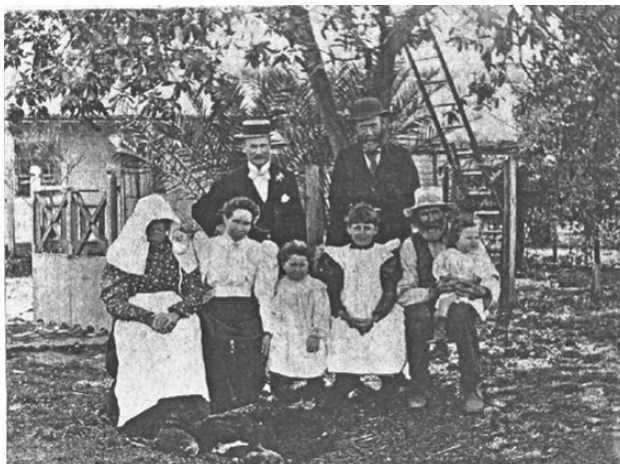
2.1.2 Undated Photograph (c.1908)

With the front gate open this early family photograph provides an excellent record of the earlier form of the ornamental gate joinery and its scale. Curiously, between this photograph and the previous one the gate hanging arrangement appears to have changed with the ornamental gateposts being removed by this later photograph.

The unidentified tree behind the family group has a ladder propped against it suggesting the possibility of it being a fruit tree. (The same tree has gone by about 1917.) A deciduous shrub is evident against the house verandah while the conspicuous foliage of two date palms (*Phoenix* sp.) dominates the garden behind the group. The type of date palm is intriguing as it looks much like the Canary Island Date Palm (*P. canariensis*) though at this time the species was only becoming available in Australia and was mostly used experimentally by the Royal Botanic Gardens, Sydney for sites such Macquarie Street and Centennial Park. More likely it is one of the other date palm species such as *P. sylvestris* or *P. dactylifera*.

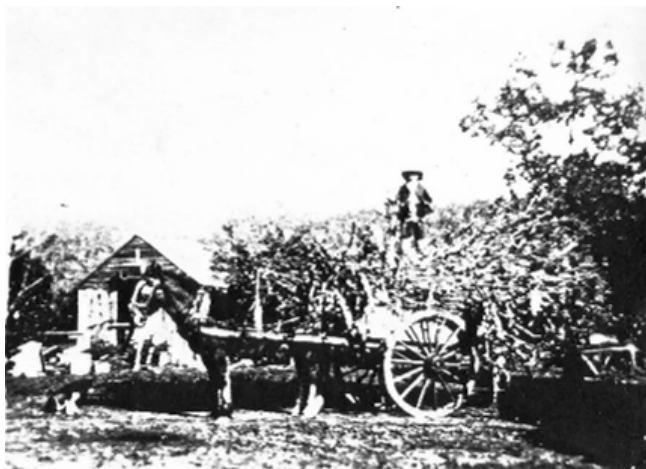
2.1.3 Undated Photograph (c.1915)

Evident in this photograph of the stables block is the taller tree to the right (Kurrajong?), a small spreading tree to the right of the stables, the branches of another tree to the left of the building (one of the existing citrus trees?) and the relatively clear views through to the escarpment beyond suggesting little screening vegetation in between at this time.

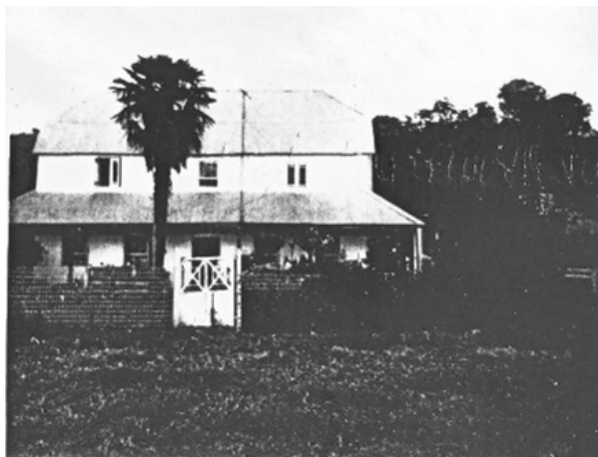
2.1.4 Undated Photograph (c.1965)

This mid-1960s photograph shows a relatively bare garden where almost all of the vegetation of earlier views has gone. The Chinese Windmill Palm (*Trachycarpus fortunei*) – so much a feature of the present garden – was probably introduced during the interwar period.

The front fence has been replaced by wire mesh panels while the ornamental gate is still present but with a different post support system.

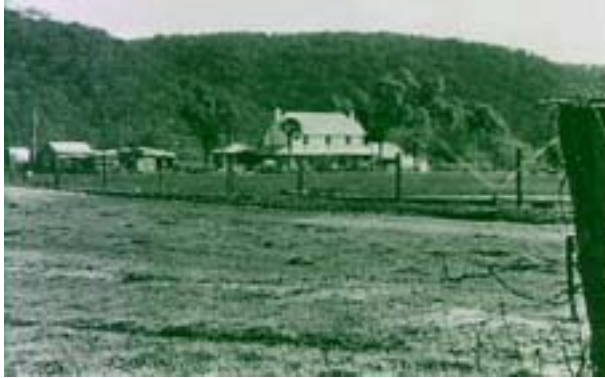
2.1.5 Undated Photograph (c.1960s?)

This photograph appears to have been taken from within the southern of the two main front paddocks of Hadley Park with the dividing fenceline in the foreground. Very little taller vegetation is evident in front of the building group with only the conspicuous Chinese Windmill Palms (*Trachycarpus fortunei*) being the most obvious.

Lower plantings are evident in the front garden while the upper canopies of some plants can be seen above the profiles of outbuildings to the left. Some vegetation can be seen to the immediate south of the front milking shed.

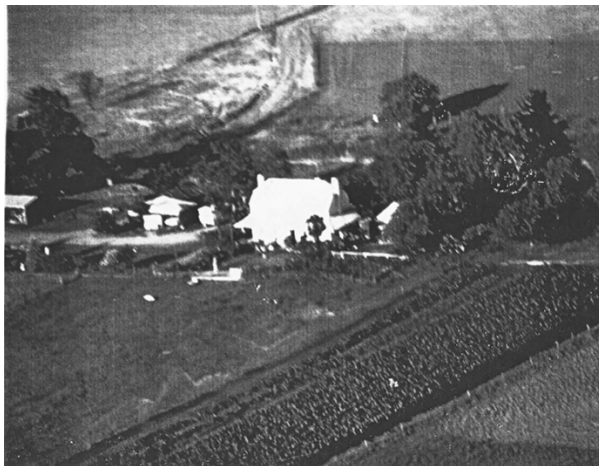
2.1.6 Undated Oblique Aerial Photograph (c.1971)

A notable feature of this excellent, and rare, oblique aerial view of Hadley Park is the large block of mature vegetation to the northwest of the house. Among these trees would be the Peppercorn Trees and Kurrajongs known to have been planted in the 19th century as well as the unmistakable profile of a large conifer.

The view also shows that the ornamental front gate is still present, a kitchen garden is well in evidence to the northeast of the house (along with fencing), the earlier access road to the creek clearly sweeps past the stables and old citrus trees, and the creek channel is surprisingly devoid of taller vegetation.

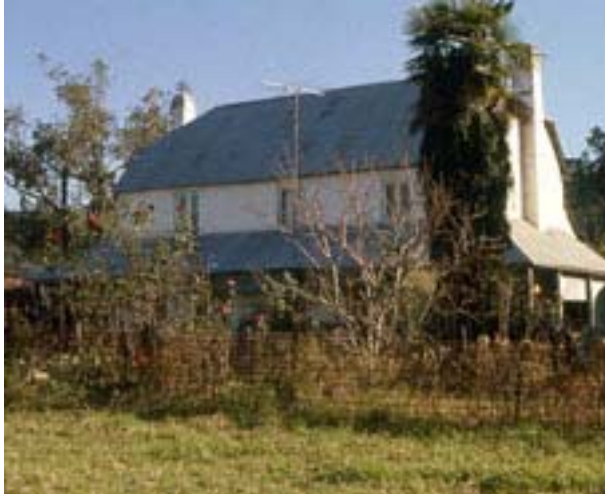
2.1.7 May 1978 photograph

Despite being a narrow view of the homestead this photograph reveals a Chinese Windmill Palm (since blown over) covered below with Cat's Claw Climber (*Macfadyena unguis-cati*) at the northeast corner of the homestead; a young White Cedar (*Melia azedarach* var. *australasica*) to the south of the homestead and various shrubs (or young trees) and perennials in the front garden.

The front fence at this time was a wire mesh panel fence.

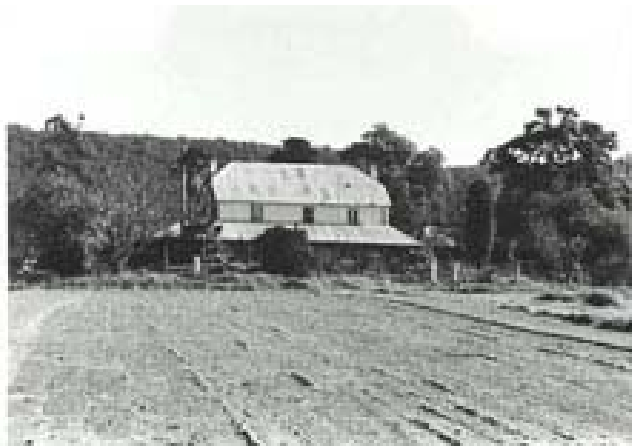
2.1.8 July 1986 photograph

Apart from the earliest archival and 1971 aerial photographs this 1986 view is one of the most helpful of the main homestead area.

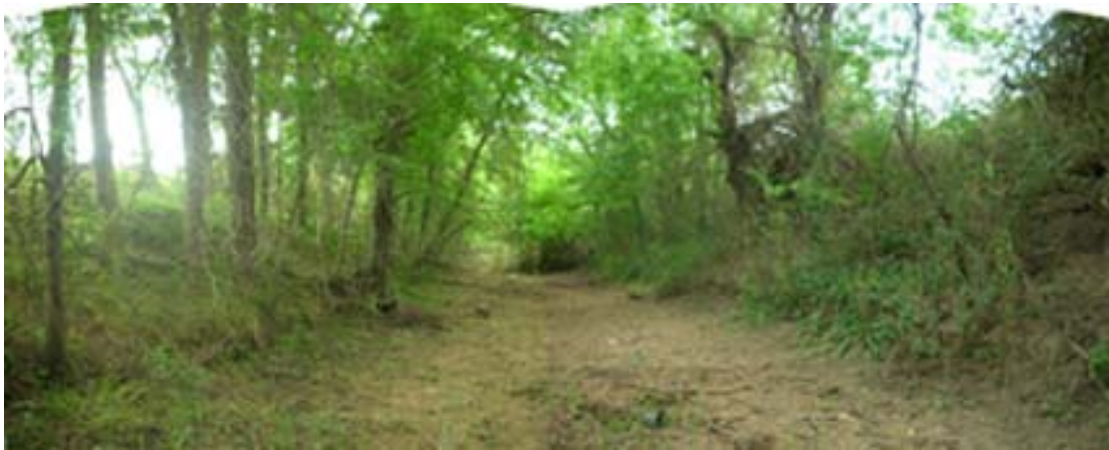
ABOVE: A late 2006 view within the former Cranebrook Creek channel at Hadley Park looking north. Most of the enclosing vegetation is Honey Locust with some Willows and occasional remnant Cabbage Gums.

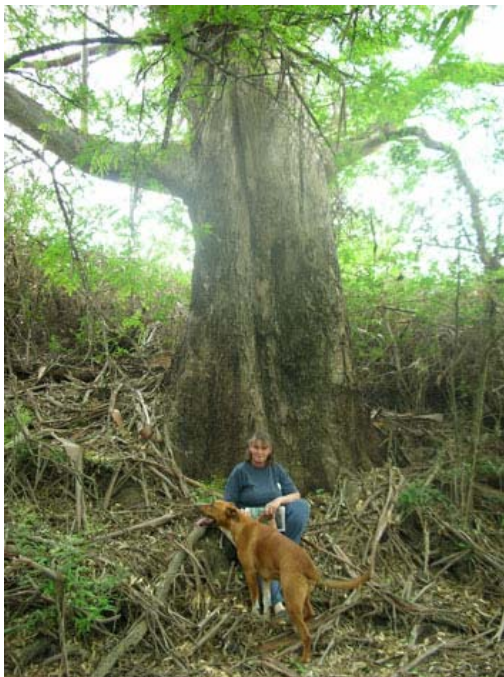
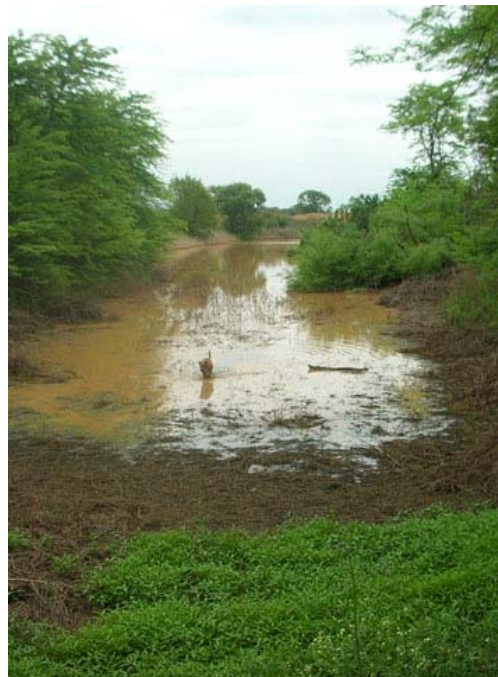
BELOW LEFT: A large remnant Cabbage Gum (*Eucalyptus amplifolia*) near the boundary with Nepean Park, 2006. **BELOW RIGHT:** The creek channel north of the causeway, 2006.

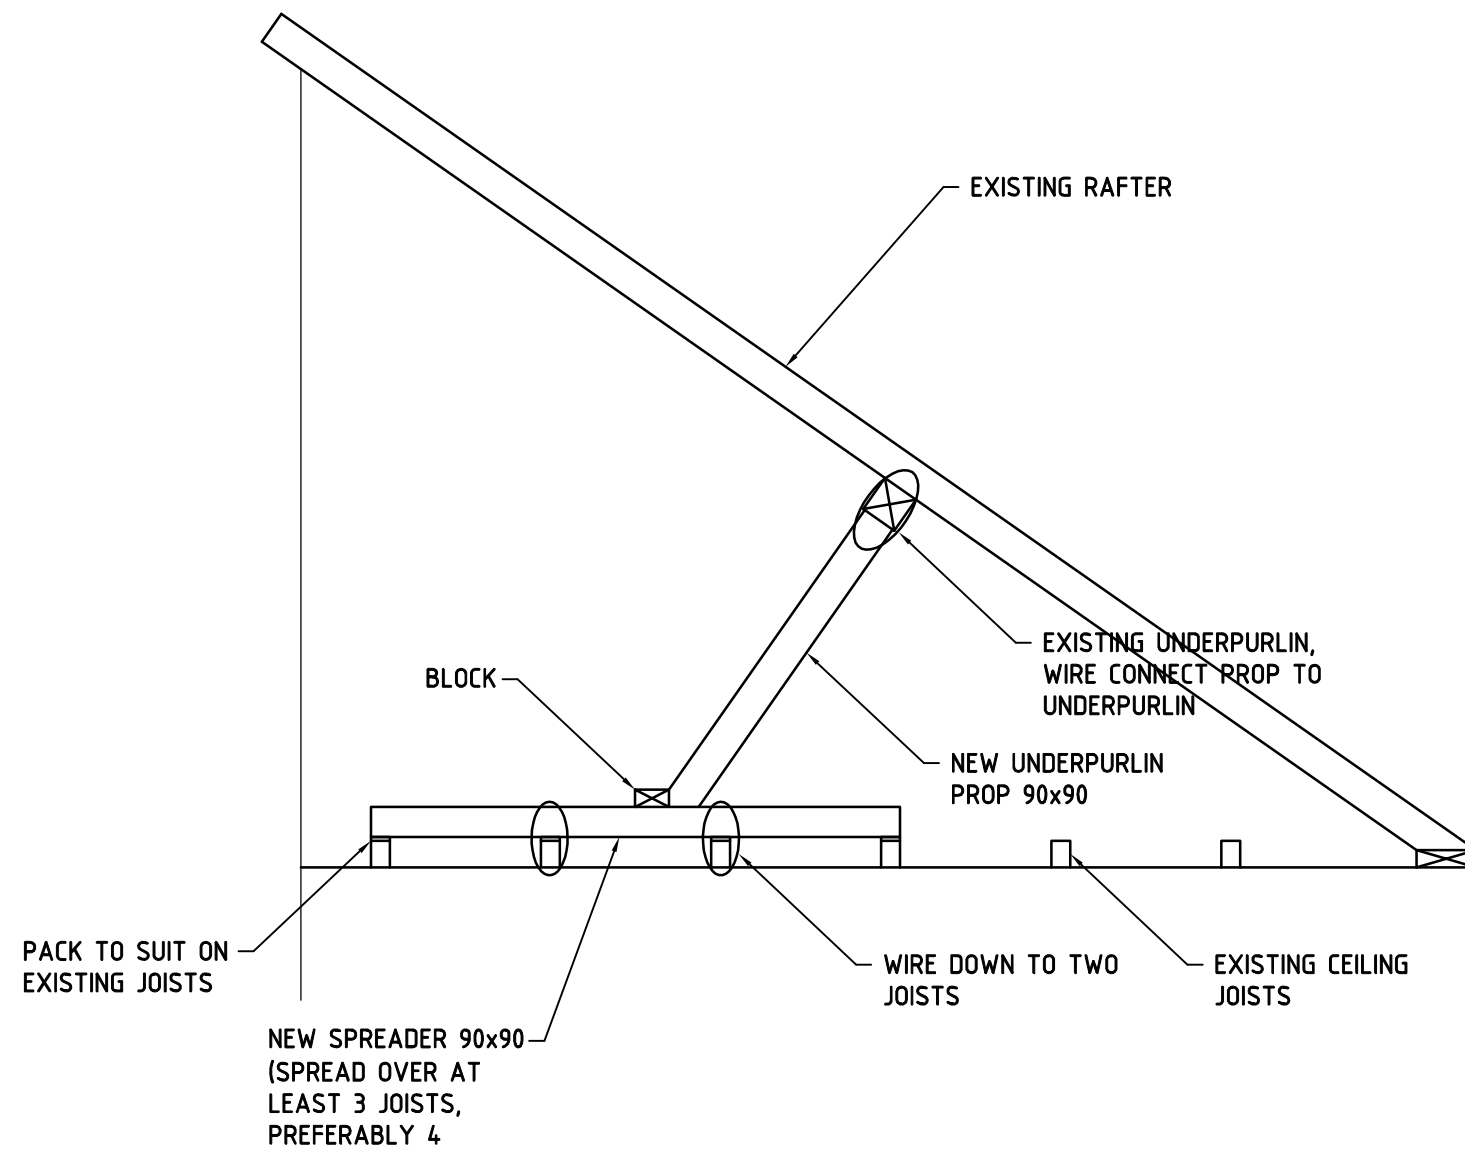
WIRES TO BE GALV 4mm FENCING WIRE.
DRILL PROPS AS REQUIRED TO SECURE WIRE.
DO NOT DRILL EXISTING TIMBERS

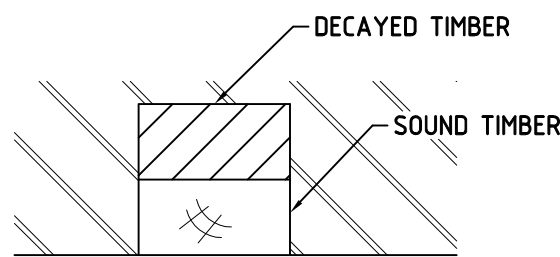
TAKE POST OUT AND AUGMENT OR REPLACE. REMOVED POST TO BE SALVAGED AND RECYCLED

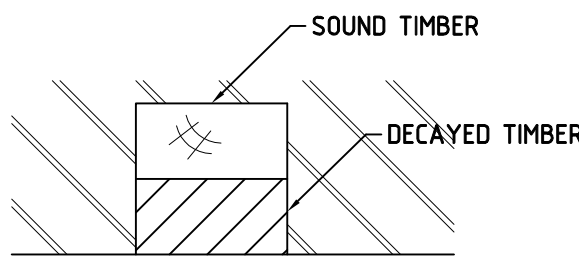
REPAIR IN SITU

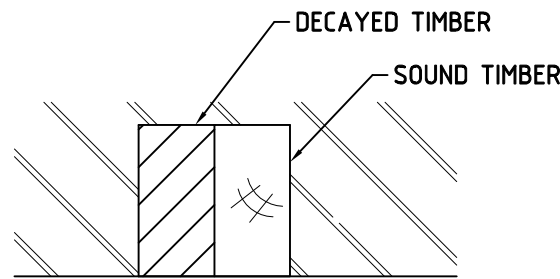
TAKE OUT AND REPAIR OR REPAIR IN SITU

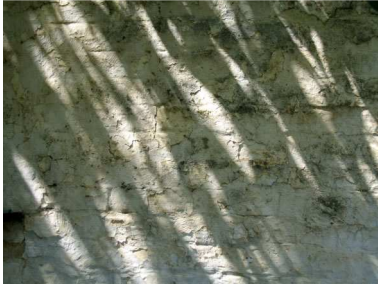
Figure 5 Hadley park masonry.

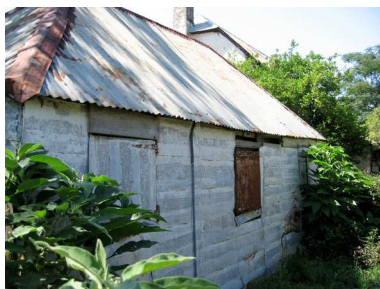
Figure 9 Timber cottage north of Hadley Park (note the metal cladding).

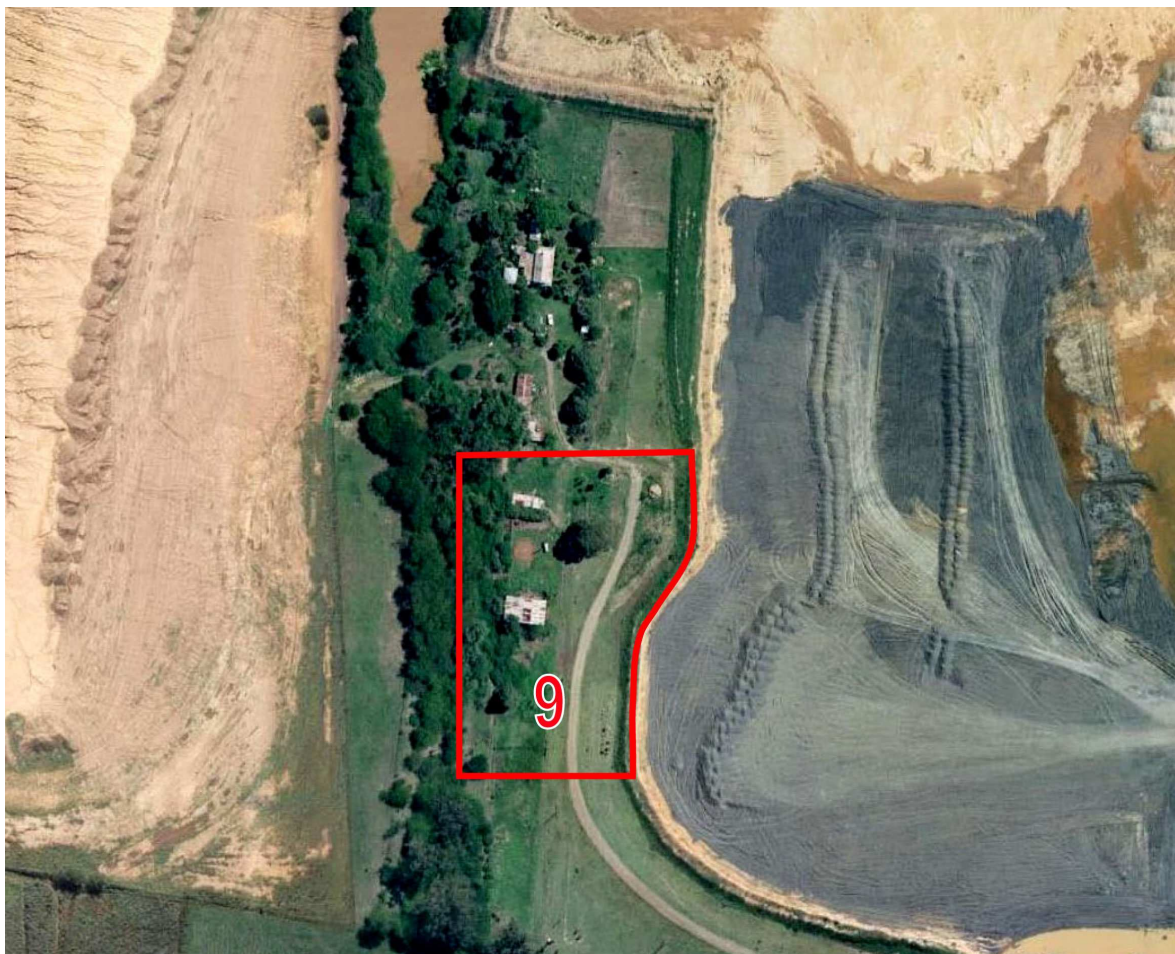
Figure 24 Aerial view of the Hadley Park group showing archaeological management Zone 9. (Base photo: Google Earth)

Do not undertake works involving ground disturbance in the area identified by geophysical survey as a potential building footprint (see Figure 24).
