Hadley Park

Conservation Management Plan

Revised Report

Report prepared for Penrith Lakes Development Corporation
September 2013

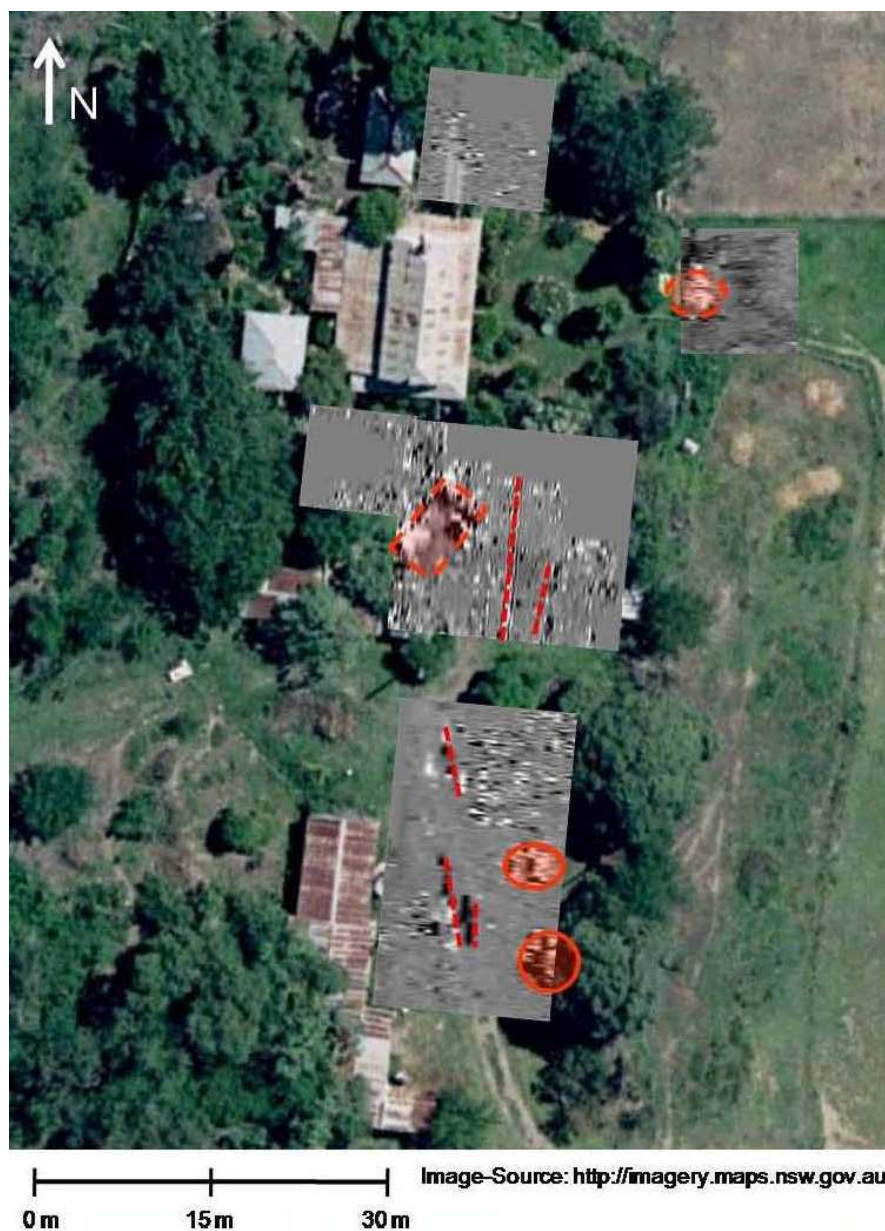
Figure 25 Ground Penetrating Radar (GPR) image showing location of former structure (dashed rectangle), silage pits (circles) and services (dashed lines). (Source: Archaeological Computing Laboratory, University of Sydney)

The site has been divided into a number of management zones below. The zones are illustrated in Figures 23 and 24. Figures 22, 23 and 24 also illustrate known structures and archaeological features at the site. The results of the geophysical survey are illustrated in Figure 25. For each management zone the following is provided:

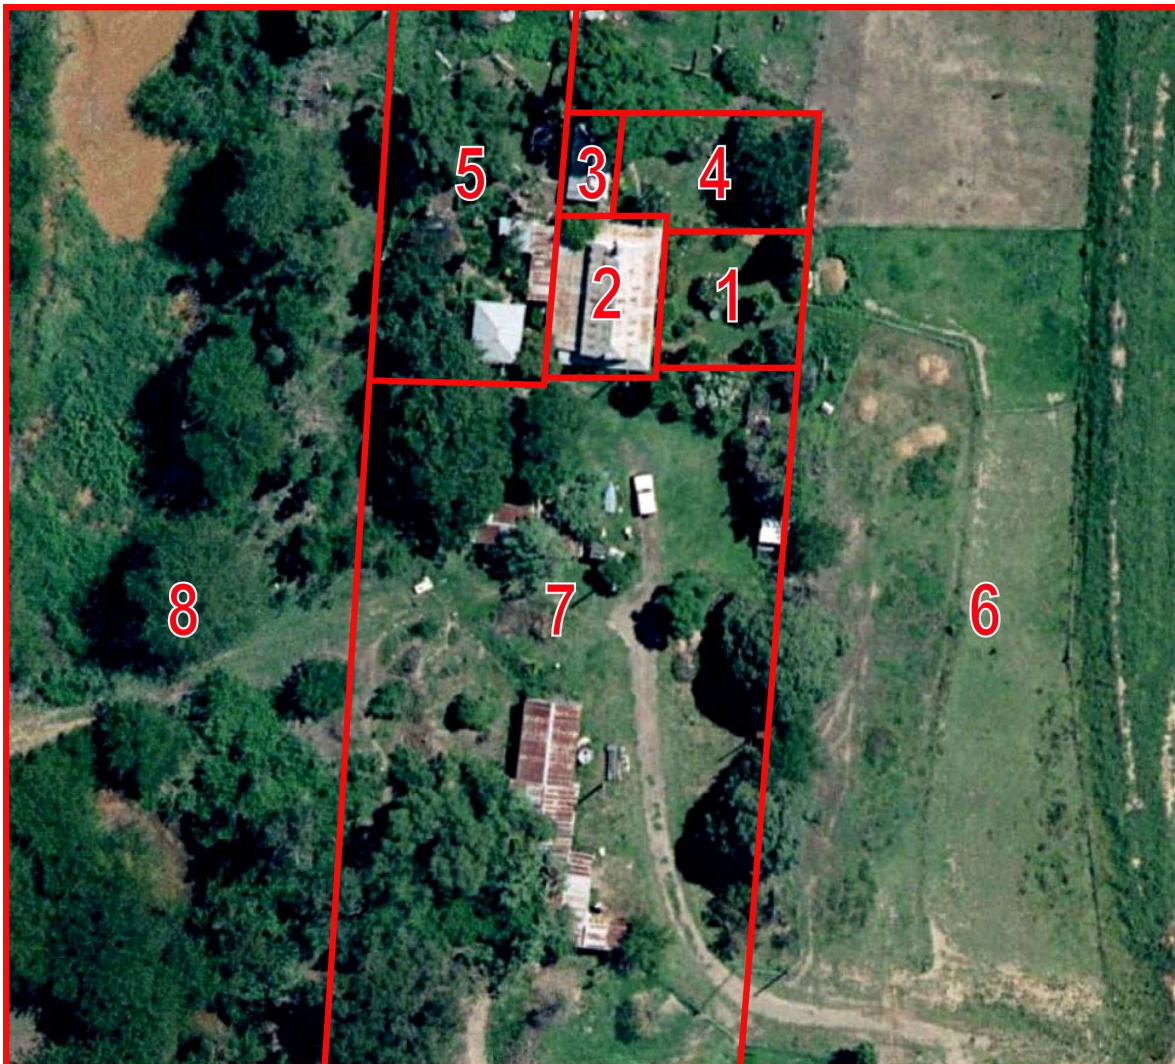
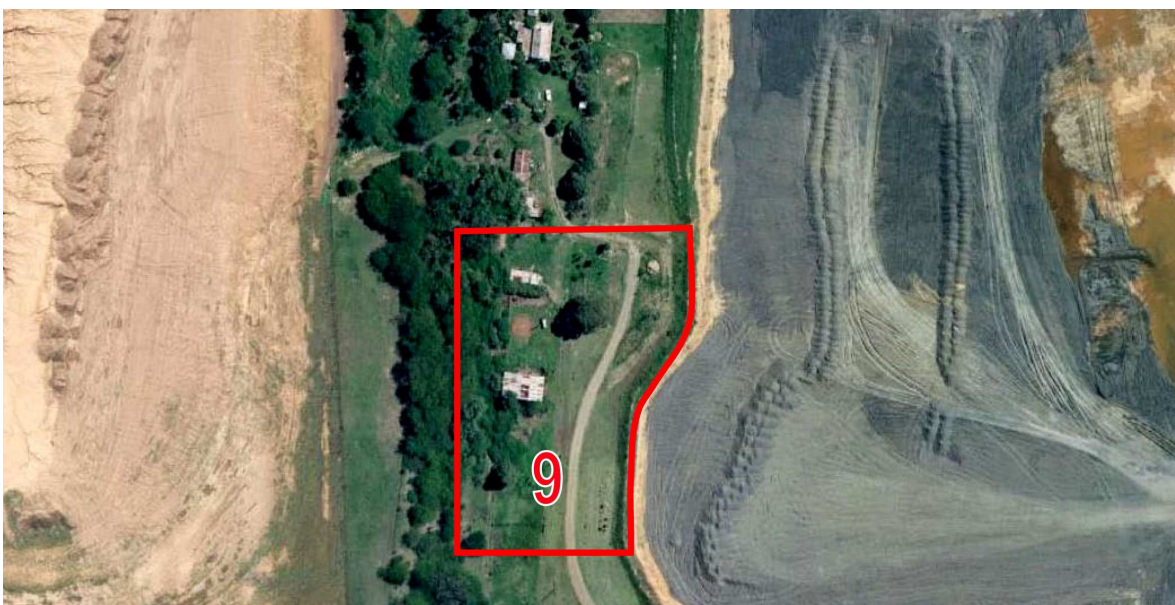
Site plans with management zones overlaid. The main residence is in Zone 2 and the slab cottage in Zone 3. (Base photo: Google Earth)
