## THE KATOOMBA COAL AND SHALE COMPANY LIMITED, WEST KATOOMBA.

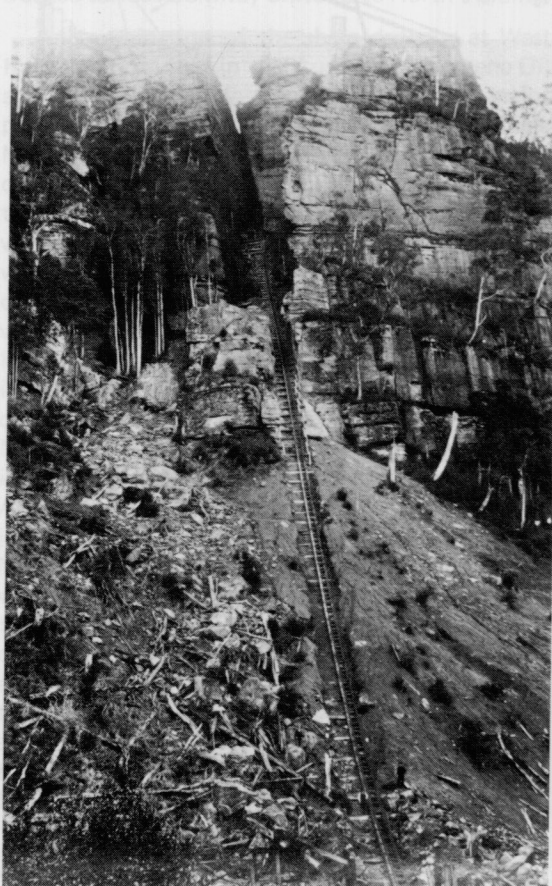
*The main incline at Katoomba at an early period prior to the laying of the second track. N.S.W.P.T.C.*
