Blue Mountains Heritage Register Review

Heritage Inventory - 2016 Heritage Review

Item Name: **Timber shop building**

Location: **23-29 Park Street, Glenbrook [Blue Mountains]**

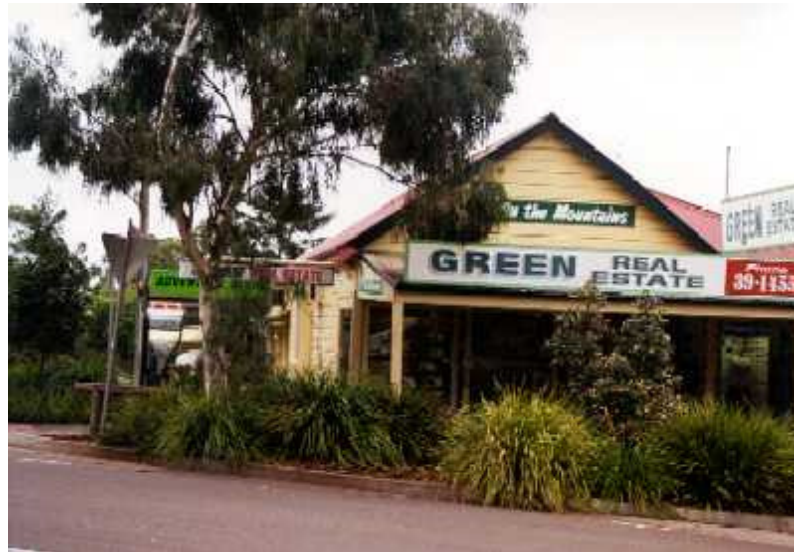
Image Number: 1170382b01

Physical Description: A single storey gabled shop facing north to Park Street with a hipped roof wing on the west side. The shop is built on the east and north property boundaries and has a skillion verandah on timber posts to the north of the main gabled section. The hipped wing has a skillion awning. The other parts of the property are now occupied by no. 23 Syd's Caffé, 25, Nifty Finger, 27, Country Blue. The Real Estate is itself no. 29, but it is an integral site.

The skillion verandah has a timber valance at the west end.

The roof is of corrugated steel and the cladding is of rusticated weatherboards.

The main gabled section was extended to the south at an early date.

Most openings on the east side, facing Ross Street, have been altered and the shopfronts have been replaced. However, the character of the original shop remains.

Caption: Timber shop building

Conserve external form of building including verandah on north side.

Conserve weatherboard cladding.

Plans to extend the verandah on the Ross Street side (which never had a verandah) should be discouraged.
