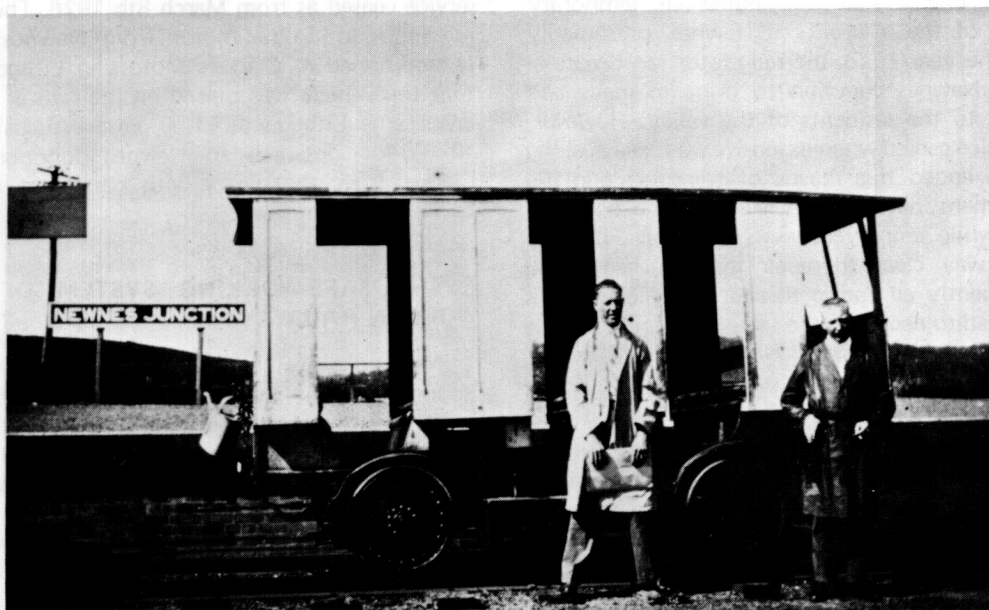
*The rail motor as rebuilt to provide protection against the winter elements.*
